September 19, 2011

Re: Lake DeTurk Dam Inspection

Lake DeTurk Dam
 Ozark Fisheries
 1100 Ozark Fisheries Rd
 Stoutland, MO 65567

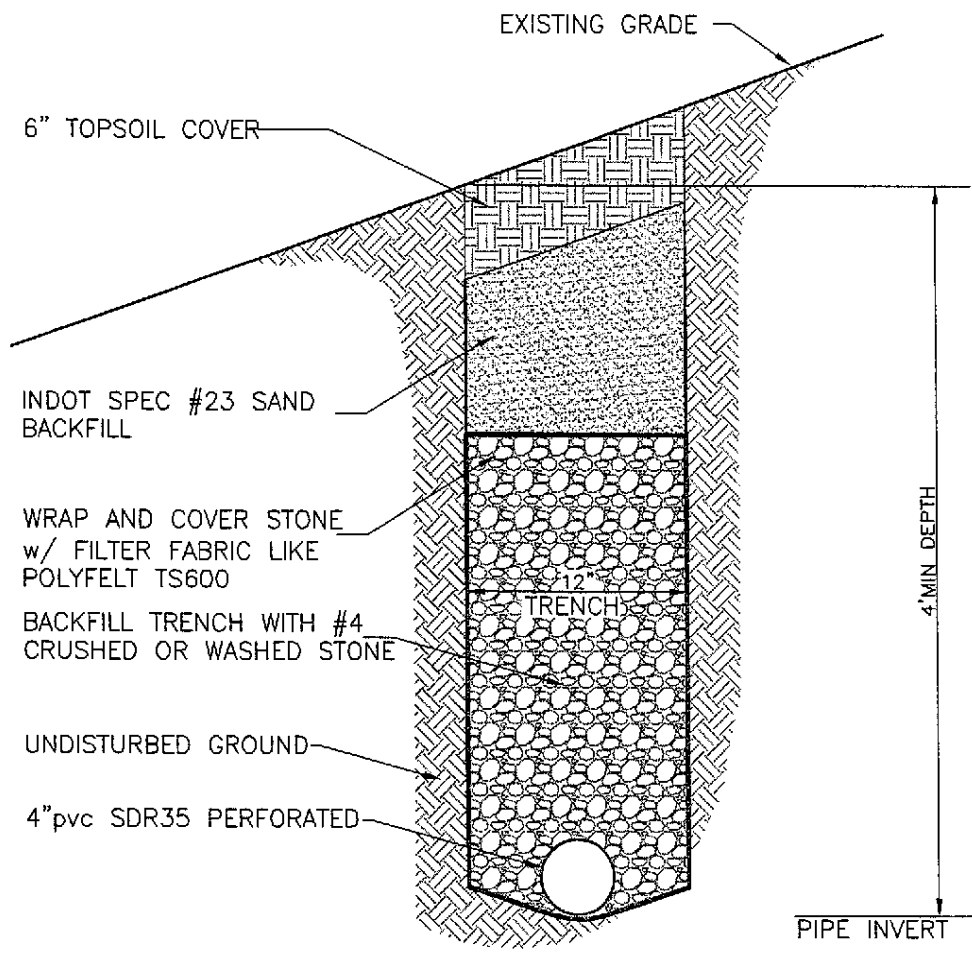
TRENCH DRAIN DETAIL

(D-10) The wet areas down slope of the spillway manhole were evaluated. It appears that the wetness may be from seepage along, or leakage of a nearby conduit. We would recommend the installation of a perforated drain tile above the wetness to a depth of about 4 feet to capture any flow. This will allow the surface to dry up. It will also facilitate observation of water quality and quantity exiting the drain. A drain tile detail is attached for reference.
