HAZARDOUS BUILDINGS BULLETIN

1st Quarter 2016

VACANT BUILDINGS: AN OPERATIONAL REALITY

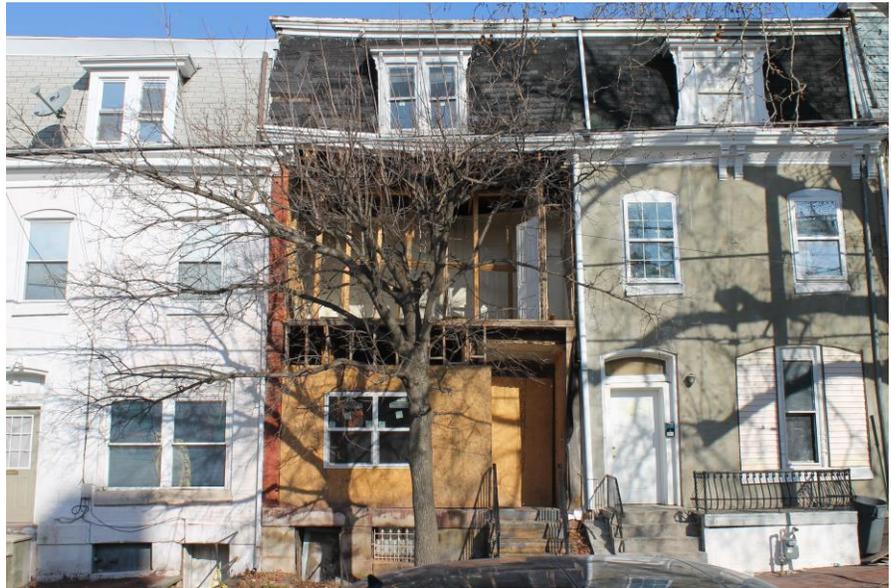
409 Elm Street.

- Front brick wall has been removed, replaced with 2x4 shoring.
- Exposures on either side are occupied.
- Notice sagging and uneven roof & gutter lines.

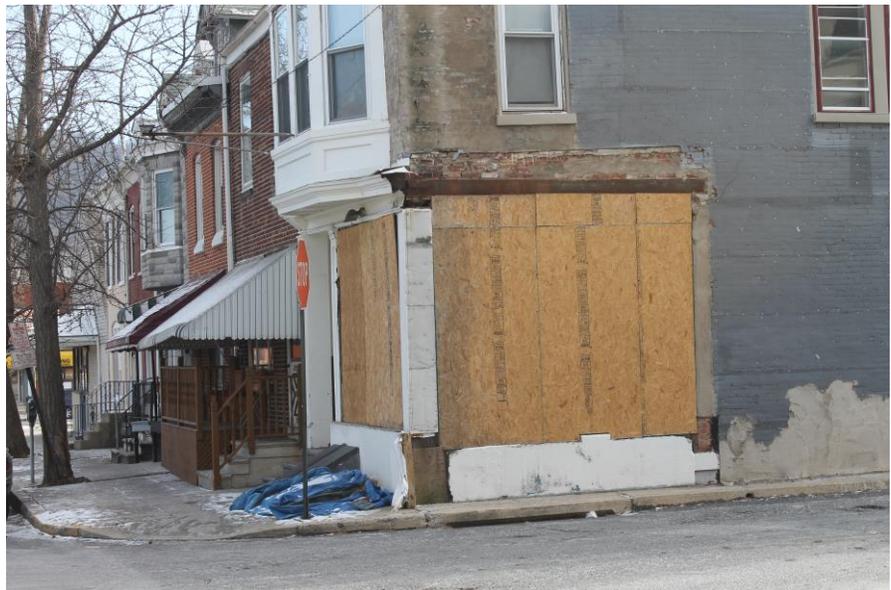
722 Walnut St

- Front Corner support removed or modified, unknown condition.
- Significant fire on first floor could cause significant collapse.

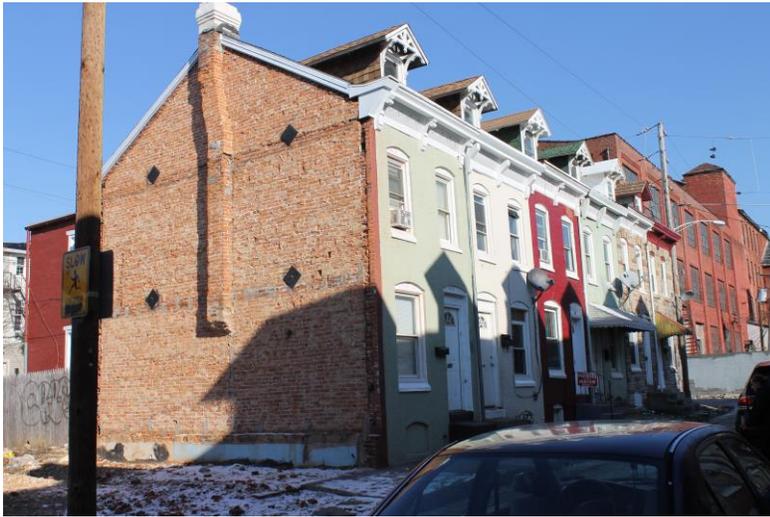
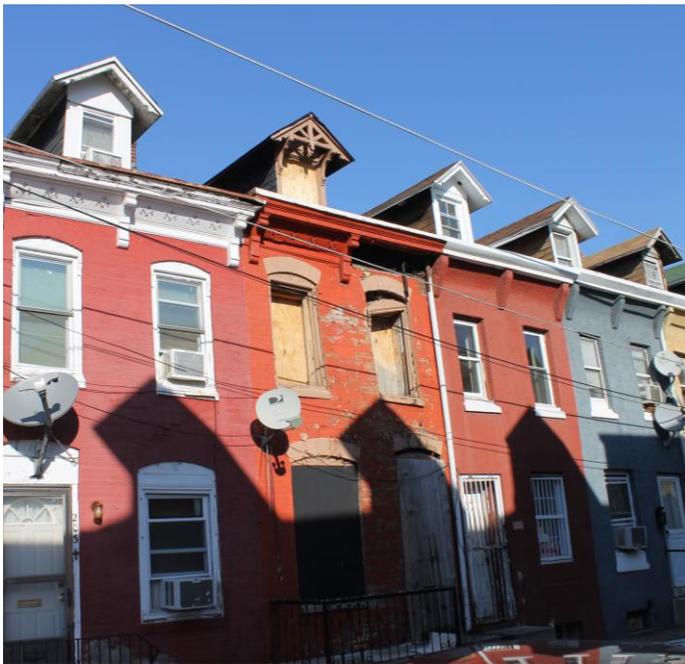
200 Block Hudson St

- Many buildings on the block have suffered previous fire damage over the years.
- Demolition and removal of adjoining contiguous dwellings has further weakened the remaining structures. (note the use of diamond plate tie-rods)
- Failure of lintel and brickwork on 2nd floor of dwelling evident in lower photo

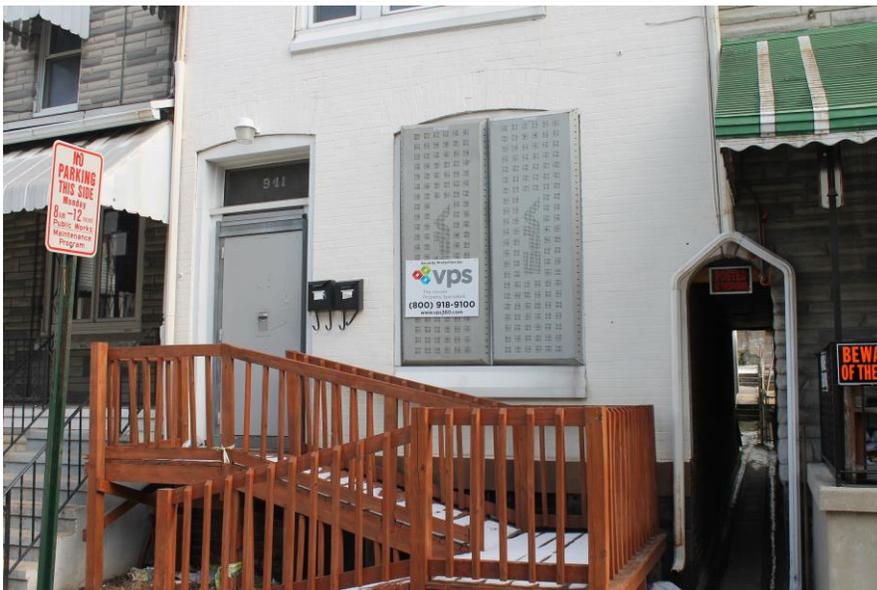
941 N 11th Street

Securing properties has always been a concern. Metal bars, ½" plywood, or newer methods such as the VPS system (Pictured at left), are common.

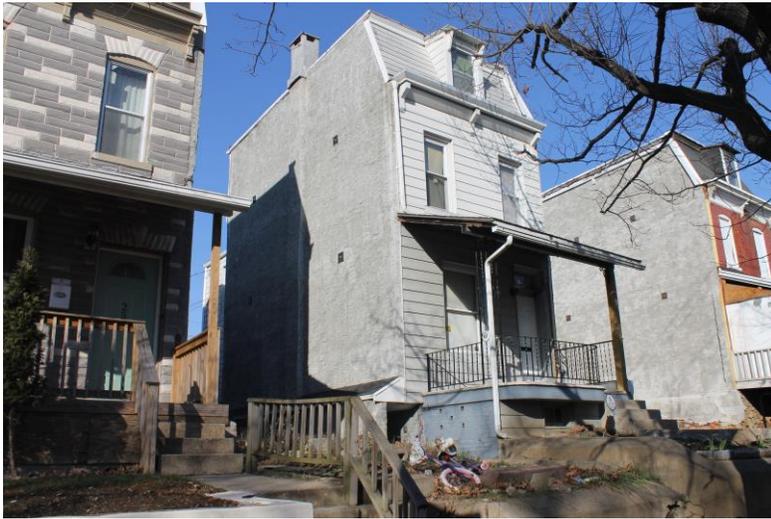
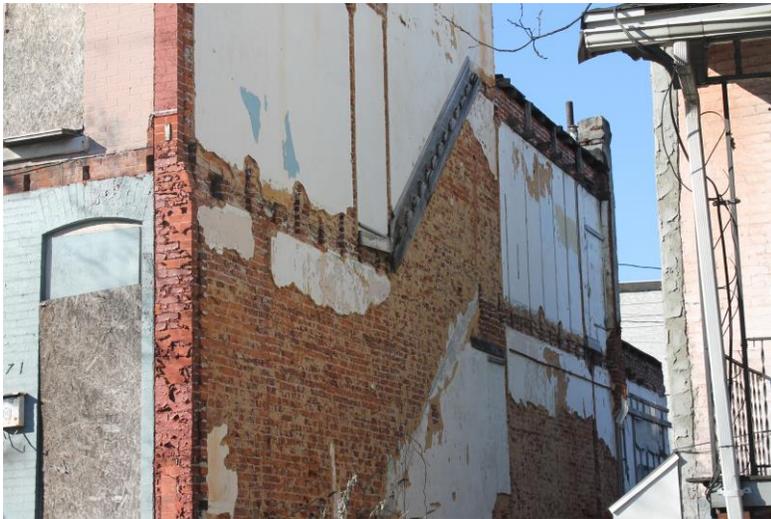
200 Block W Buttonwood

**“Stand alone”
dwellings that were
formerly row
dwellings have had
part of their stability
removed. Heavy fire
involvement could
result in an earlier
catastrophic
collapse. Note the
use of diamond
plate tie-rods. Lower
photo shows
construction
features of older
dwellings before
finishing stucco
applied. Modern
lightweight
construction fails
even sooner under
fire conditions!**
