LAKE DETURK DAM 2014 DAM SAFETY INSPECTION REPORT

LAKE DETURK CONSERVANCY DISTRICT

CHRISTOPHER B. BURKE ENGINEERING, LLC

Inspection Date: May 13, 2014

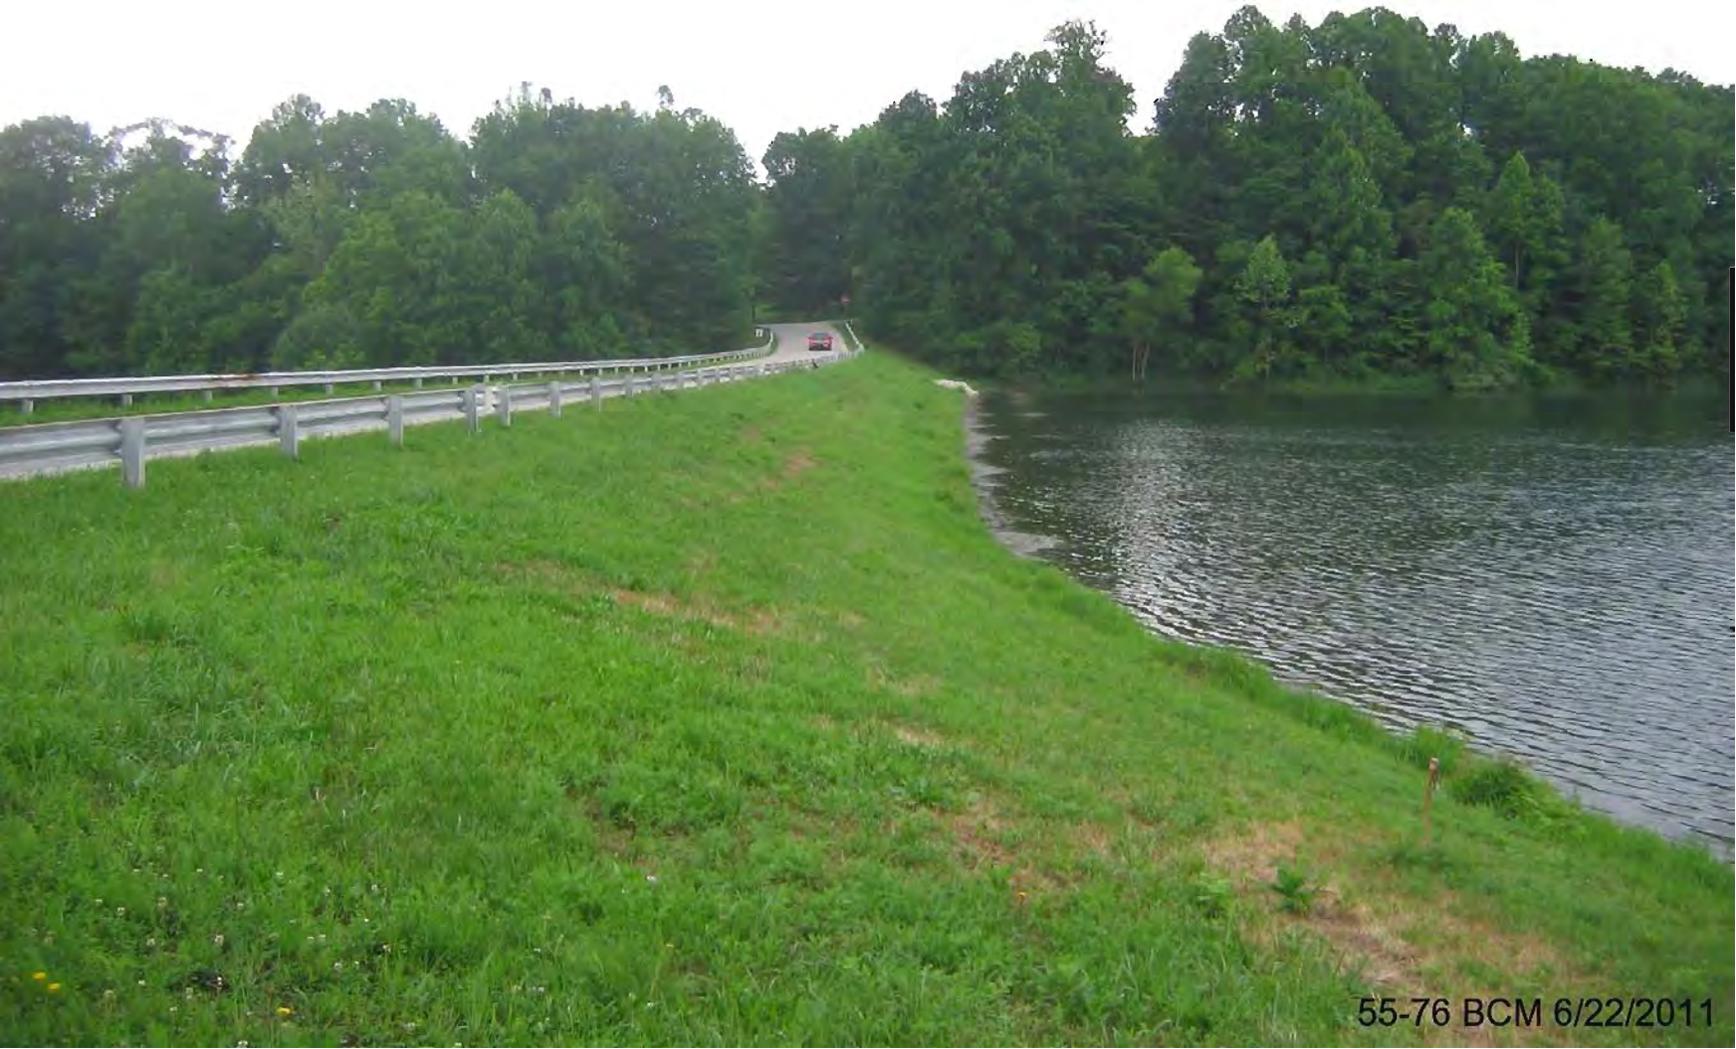
Upstream Slope

Added riprap

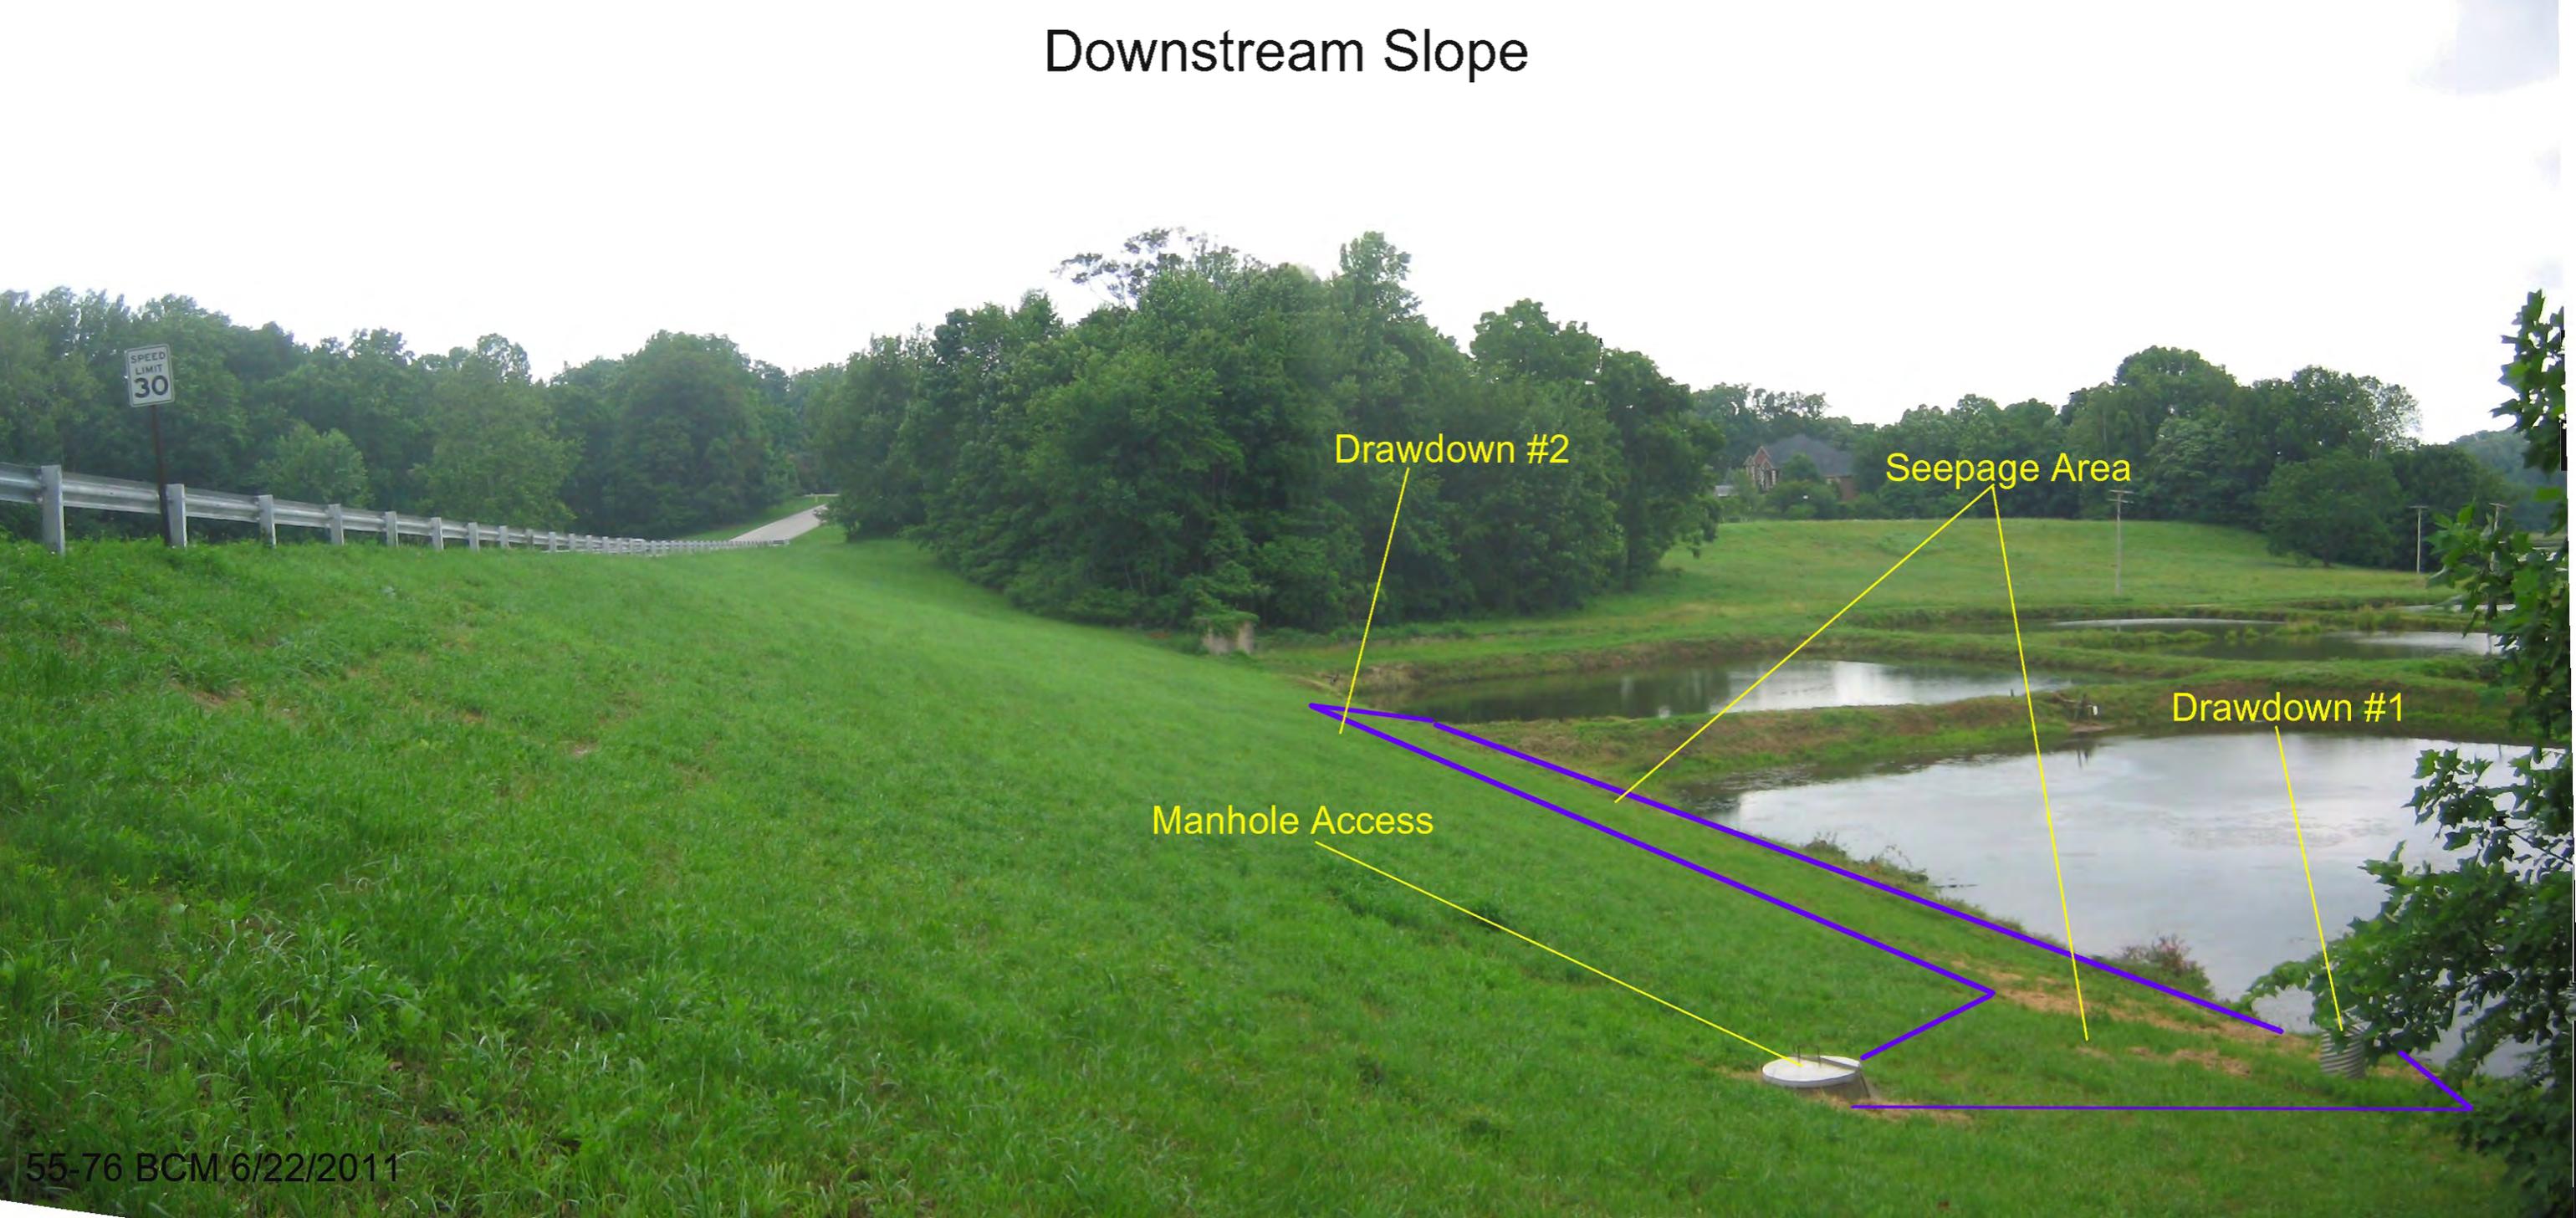
Drawdown #2

Seepage Area

Drawdown #1

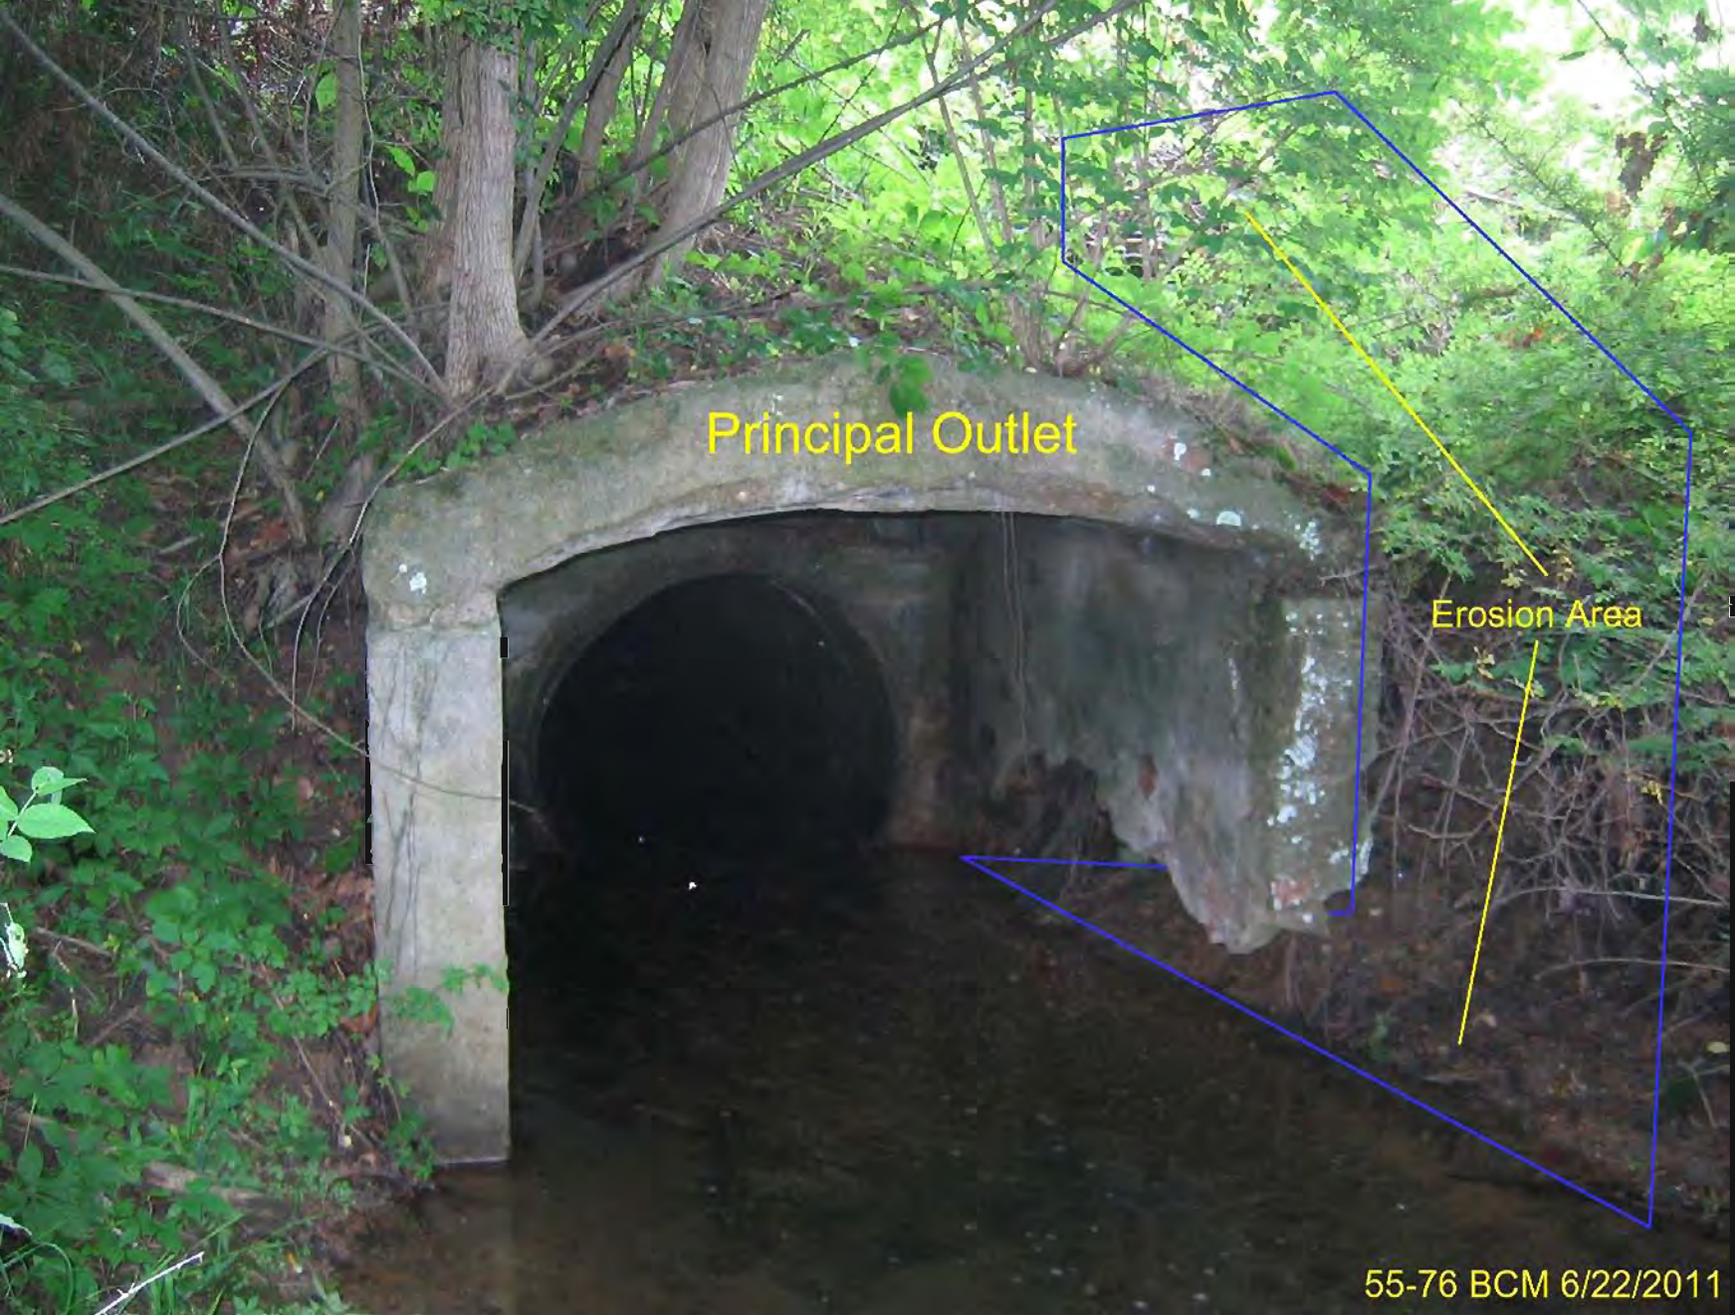
Principal Outlet

Erosion Area

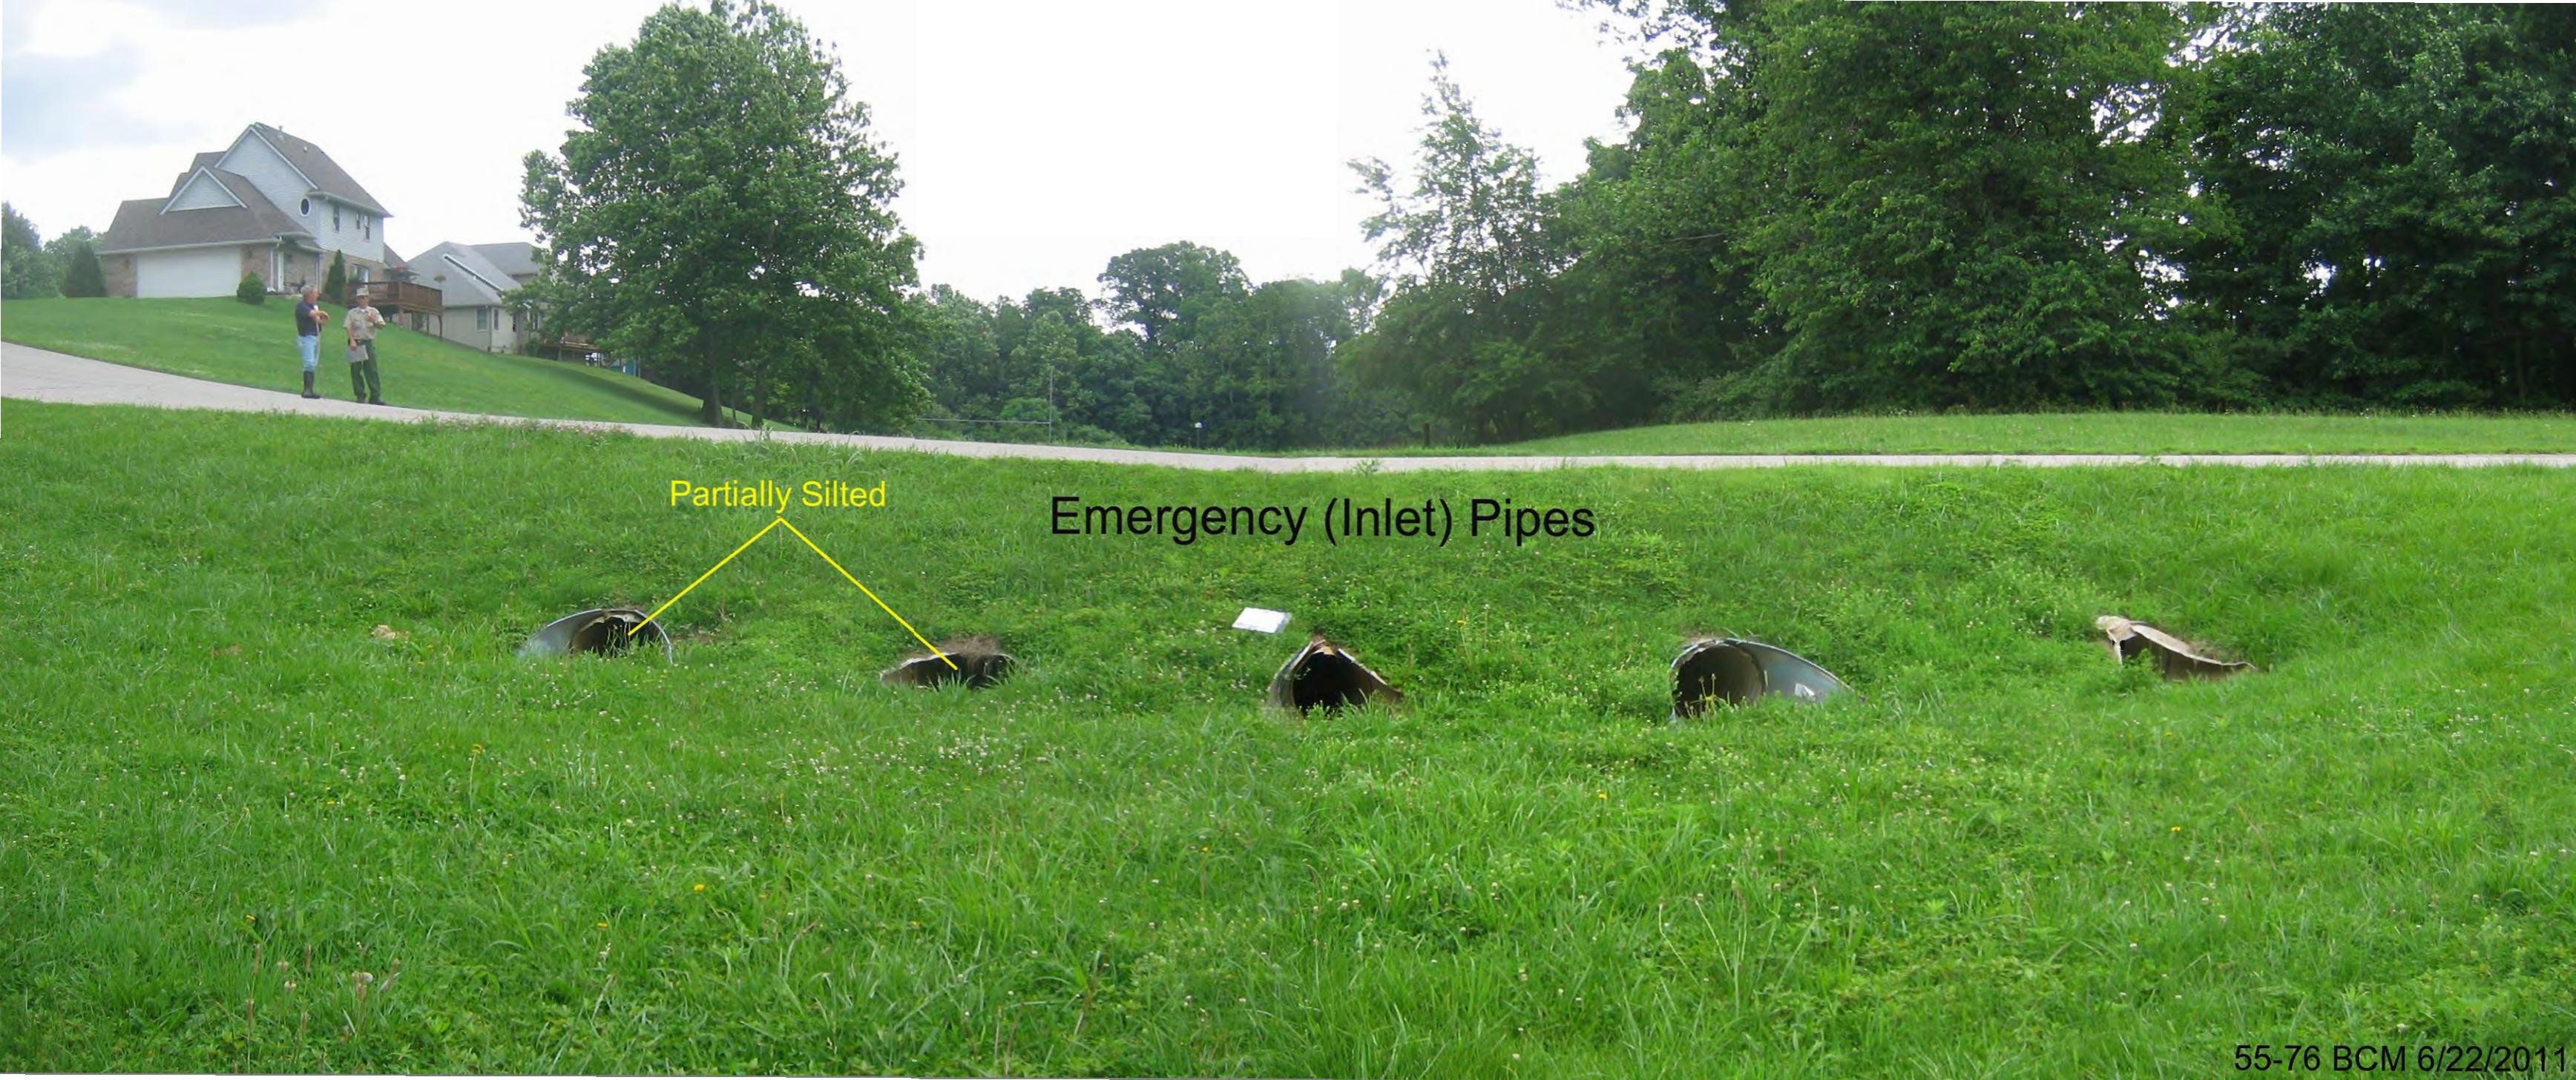
Emergency (Inlet) Pipes

Partially Silted

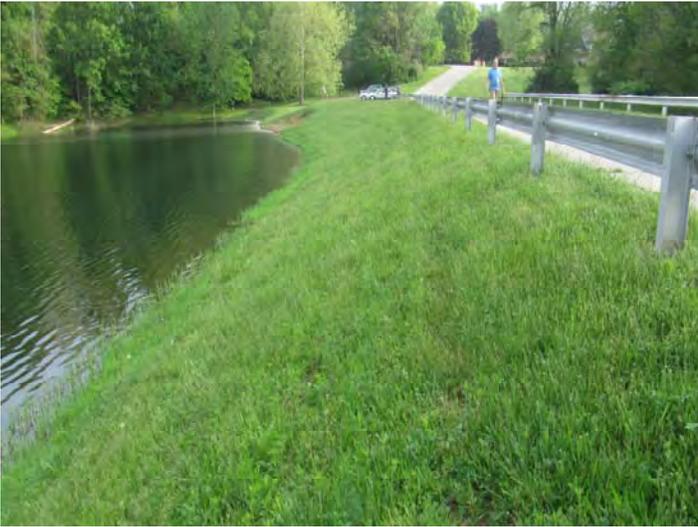
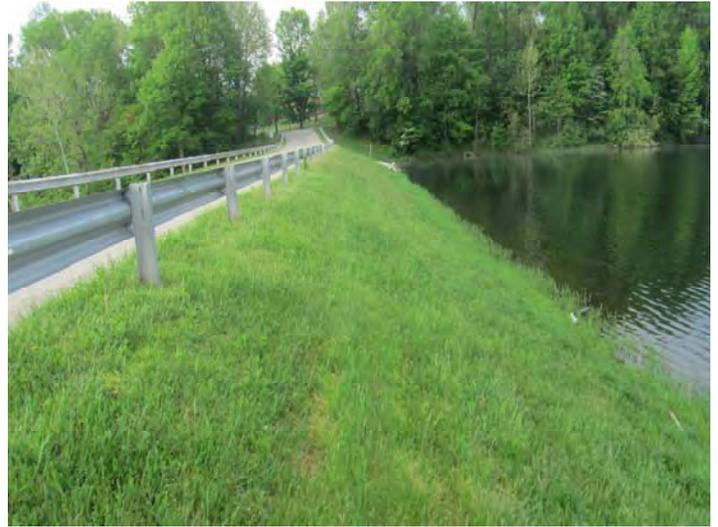
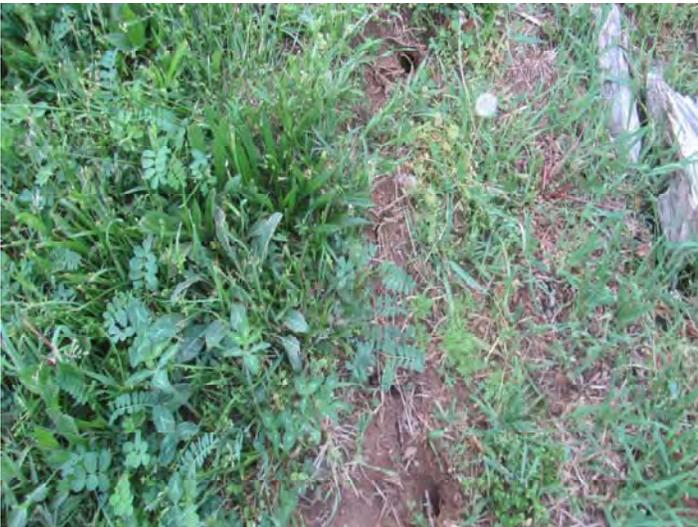
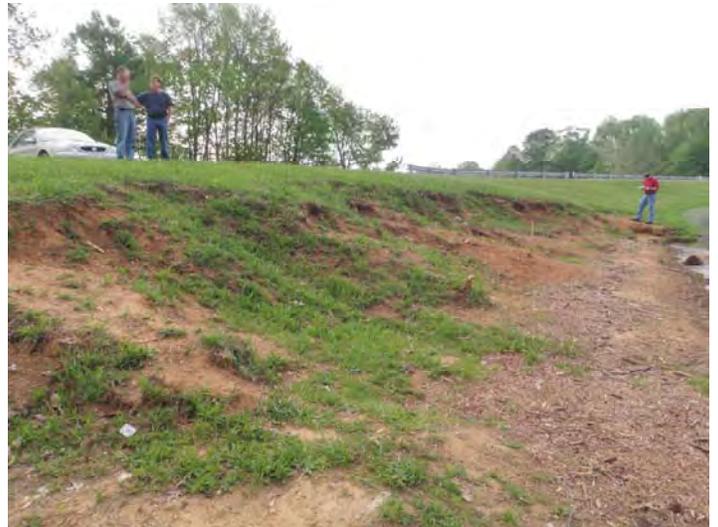
Top Left:	Upstream slope from south end of dam. Uniform slope with adequate grass cover. No slope protection present.
Top Right	Upstream slope from north end of dam. Uniform slope with adequate grass cover. No slope protection present.
Bottom Left:	Animal burrows typical along upstream slope.
Bottom Right:	Upstream slope near north end. Wave action scarping approximately 75 feet long and 4 feet high.

- Clear trees and brush from the right abutment on the upstream slope
- Backfill animal burrows as seen on the upstream slope
- Place riprap along the upstream slope for erosion protection
- Repair scarp near the left end of the upstream slope

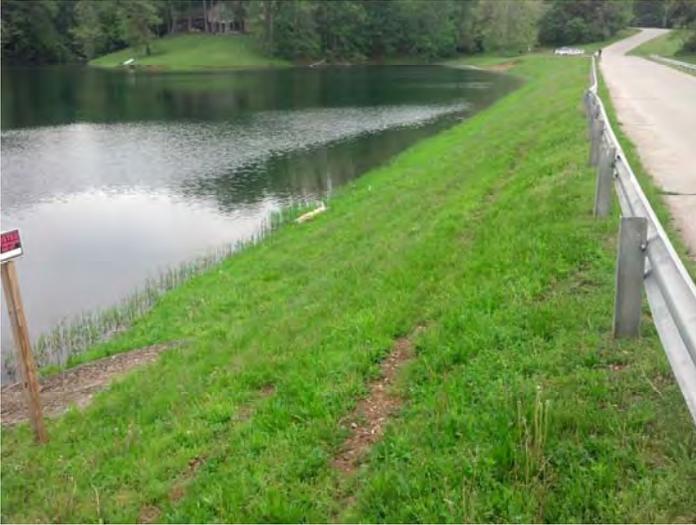
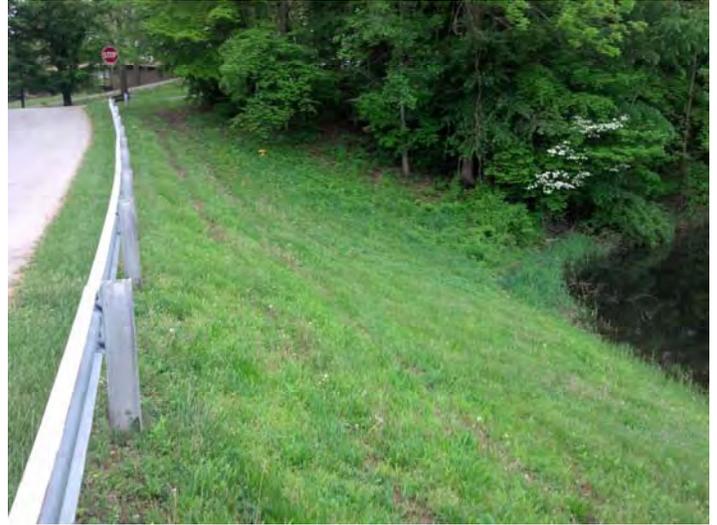
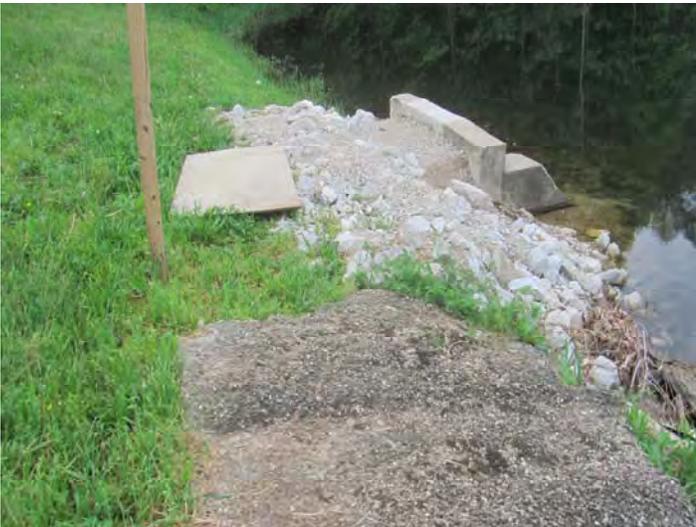
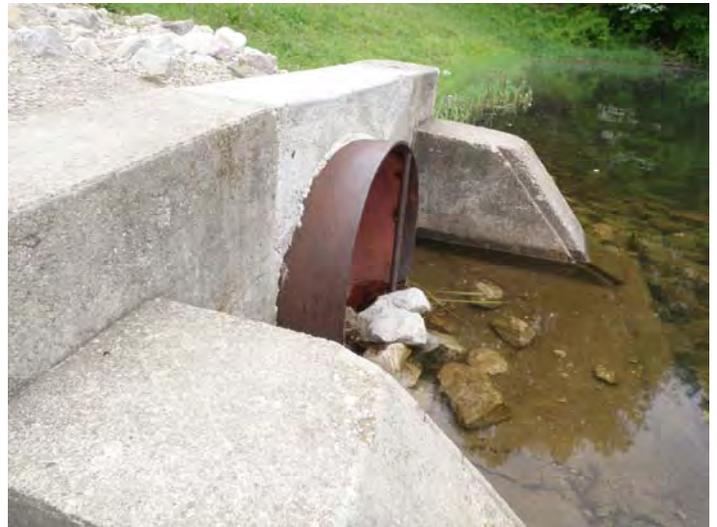
Top Left:	Upstream slope from south end of dam. Rutting observed along entire slope likely from mowing.
Top Right:	Upstream slope near south end of dam. Dense brush and trees have overgrown the right abutment.
Bottom Left:	Principal spillway inlet on upstream slope. Adequate riprap protection around headwall.
Bottom Right:	Principal spillway inlet on upstream slope. Pipe is partially obstructed by riprap, trash rack is missing bars, and headwall and apron has varying degrees of concrete deterioration.

- Clear trees and brush from the outlet of the principal spillway
- Repair/Replace trash rack at the inlet to the principal spillway
- Repair concrete headwall and apron at the inlet to the principal spillway
- Repair/Replace concrete hood at the outlet to the principal spillway
- Remove silt and debris from the emergency spillway inlet culverts
- Prepare plans and specifications to increase the spillway system capacity to meet IDNR requirements for high hazard dams

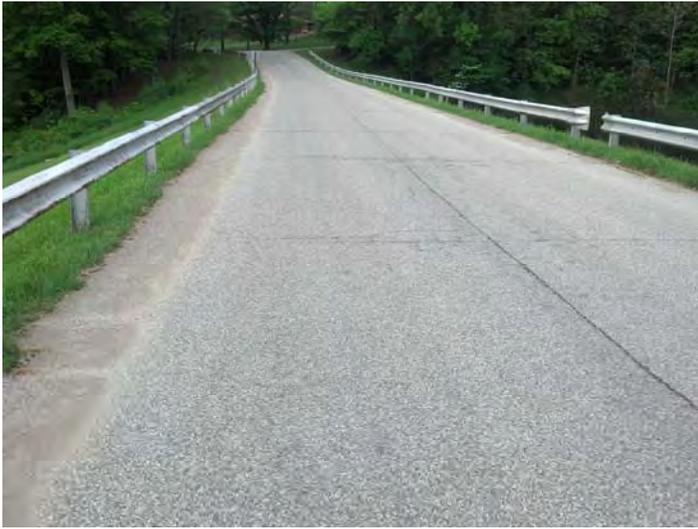
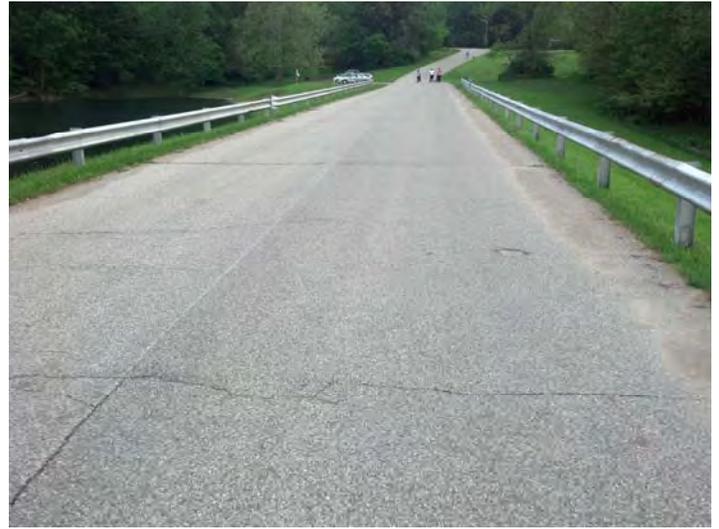
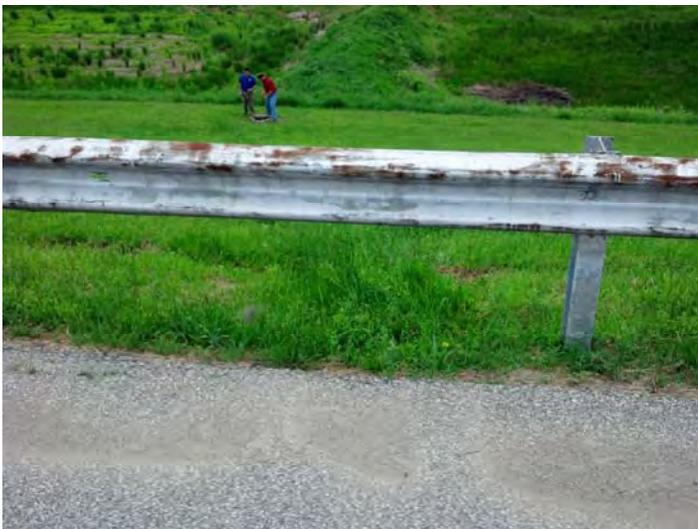
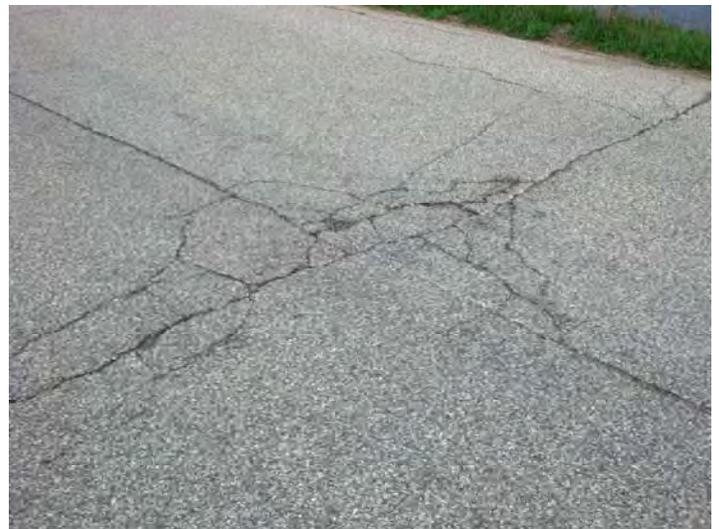
Top Left:	Embankment crest from the north end of dam. Asphalt pavement appears adequate with only minor longitudinal and transverse cracking.
Top Right:	Embankment crest from the north end of dam. Asphalt pavement appears adequate with only minor longitudinal and transverse cracking.
Bottom Left:	Embankment crest guardrail located on both the upstream and downstream side. Guardrail shows no signs of instability only minor dents and surface rust.
Bottom Right:	Asphalt cracking typical along entire embankment crest.

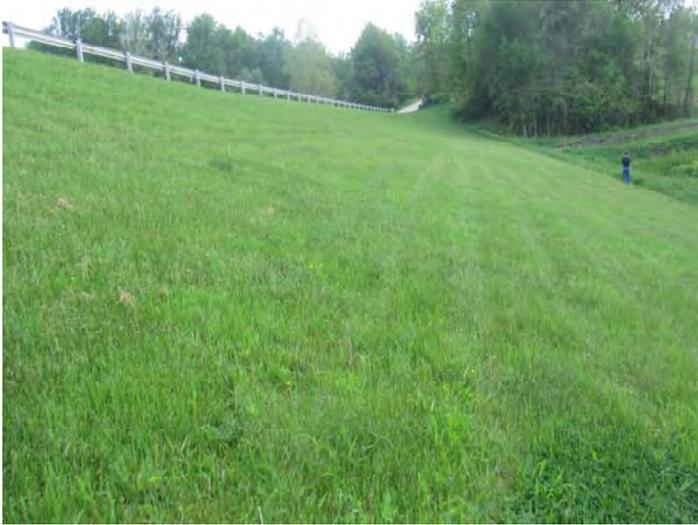
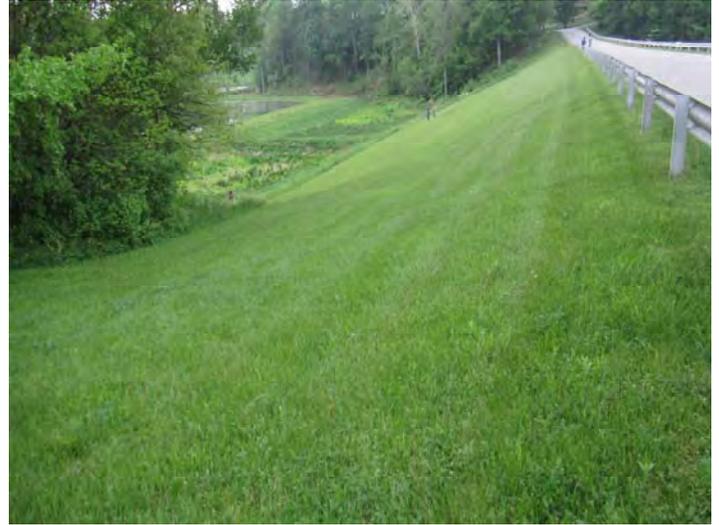
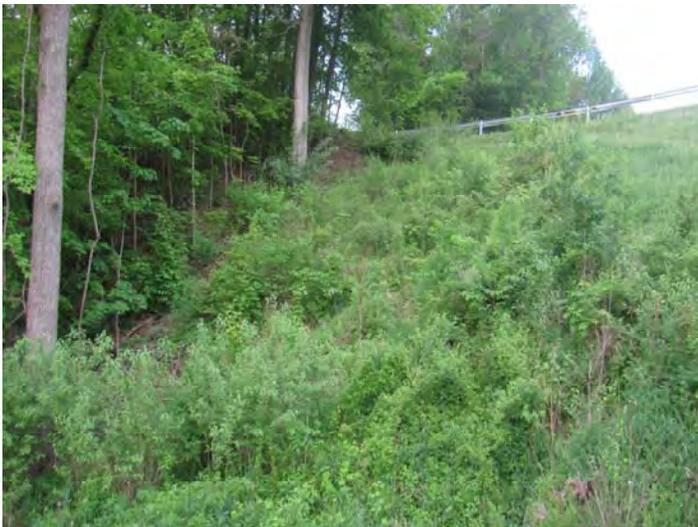
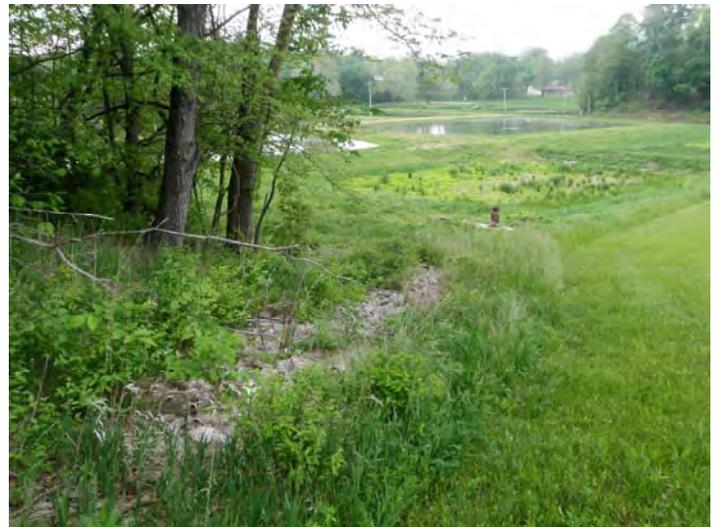
Top Left:	Downstream slope from the south end of dam. Uniform slope with adequate grass cover.
Top Right:	Downstream slope from the north end of dam. Uniform slope with adequate grass cover.
Bottom Left:	Downstream slope near south end of dam. Dense brush and trees have overgrown the right abutment.
Bottom Right:	Downstream slope near north end of dam. Dense brush and trees have overgrown the left abutment.

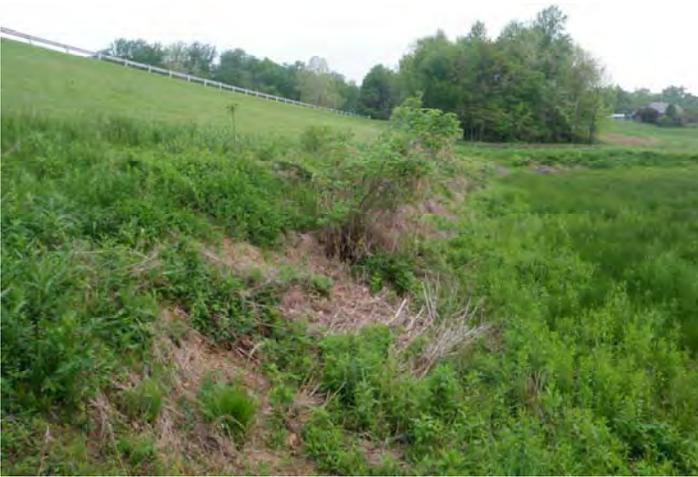
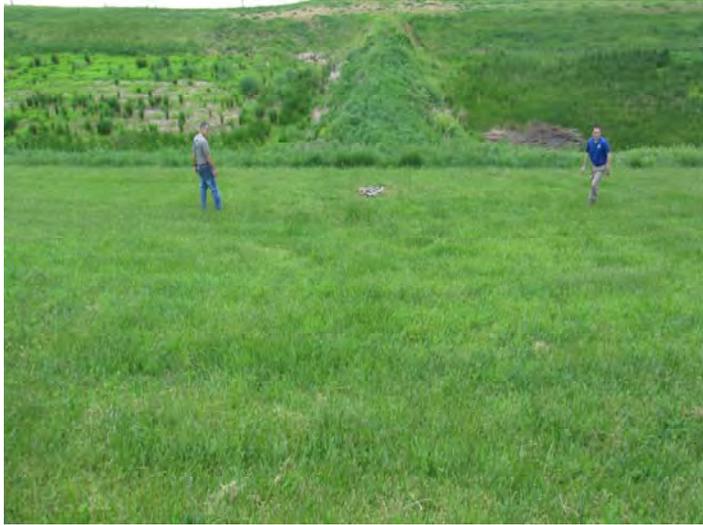
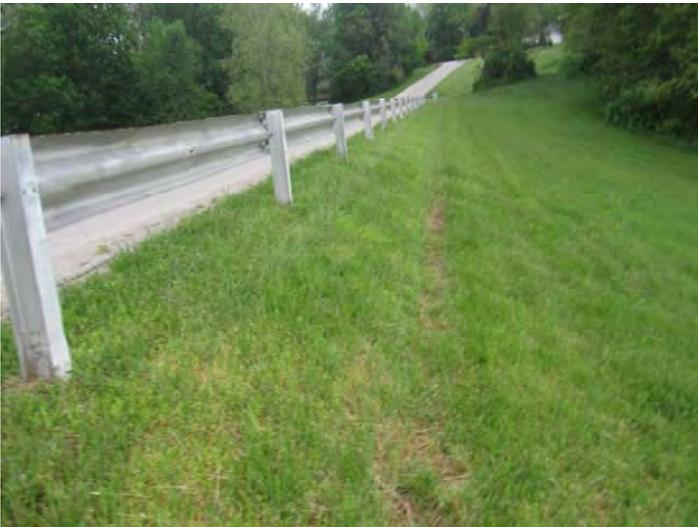
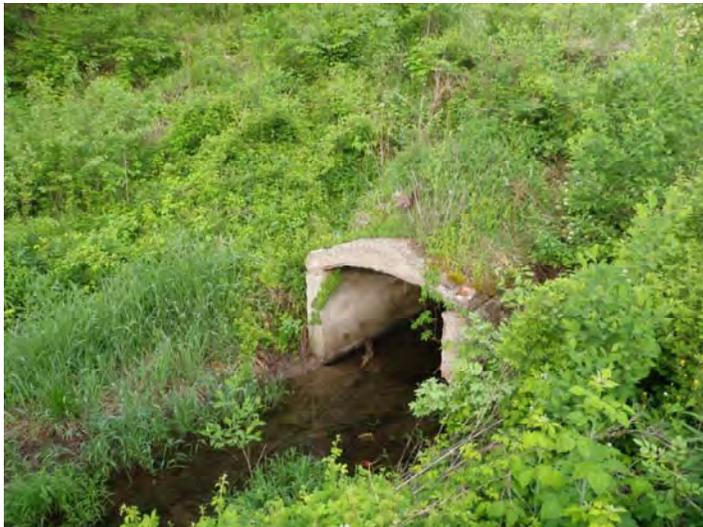
Top Left:	Downstream slope near south end of dam. Dense brush has overgrown the toe of the embankment.
Top Right	Downstream slope near center of dam. Depression area observed above lake drain. Approximately 10 feet long by 10 feet wide and 1-foot deep.
Bottom Left:	Downstream slope near center of dam. Rutting observed along entire slope likely from mowing.
Bottom Right:	Principal spillway outlet near south end of dam. Severe deterioration and undermining of the concrete hood. Dense brush and trees have overgrown the outlet area.

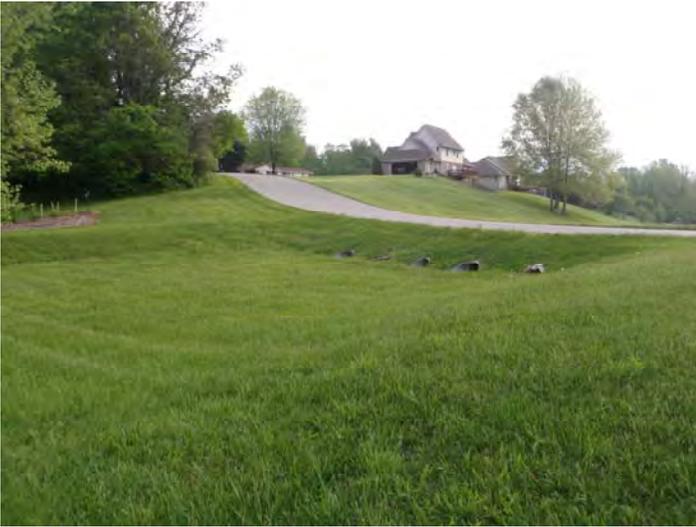
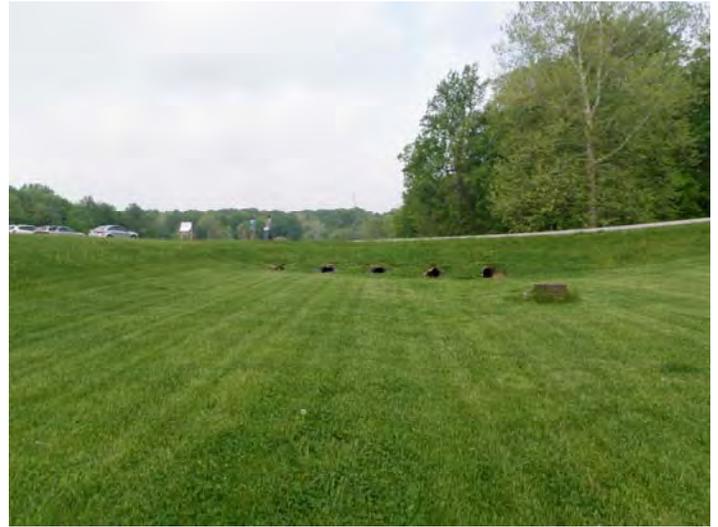
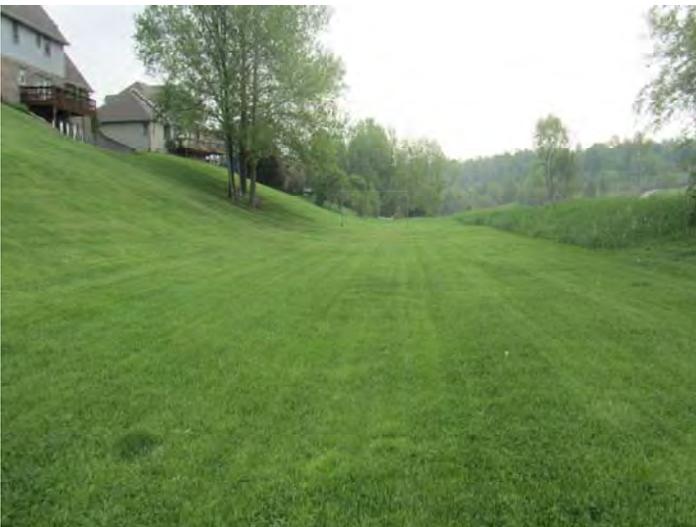
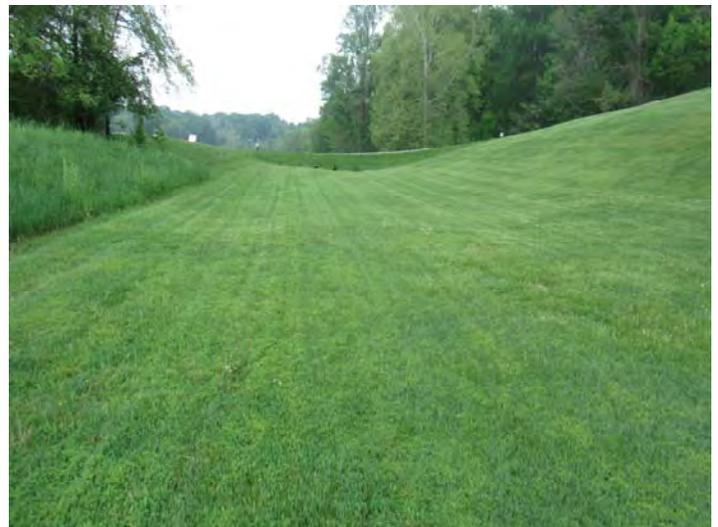
Top Left:	Emergency spillway inlet near north end of dam. Upstream inlet channel has adequate grass cover and is free of obstructions. CMP culverts and metal end sections have varying degrees of deformation and siltation.
Top Right	Emergency spillway inlet near north end of dam. Downstream channel has adequate grass cover. CMP culverts and metal end sections have varying degrees of deformation and siltation. A sanitary manhole is located in the center of the spillway channel.
Bottom Left:	Emergency spillway channel looking downstream. Adequate grass cover present.
Bottom Right:	Emergency spillway channel looking upstream. Adequate grass cover present.
