HAZARDOUS BUILDINGS BULLETIN

3rd Quarter 2016

MIXED OCCUPANCY

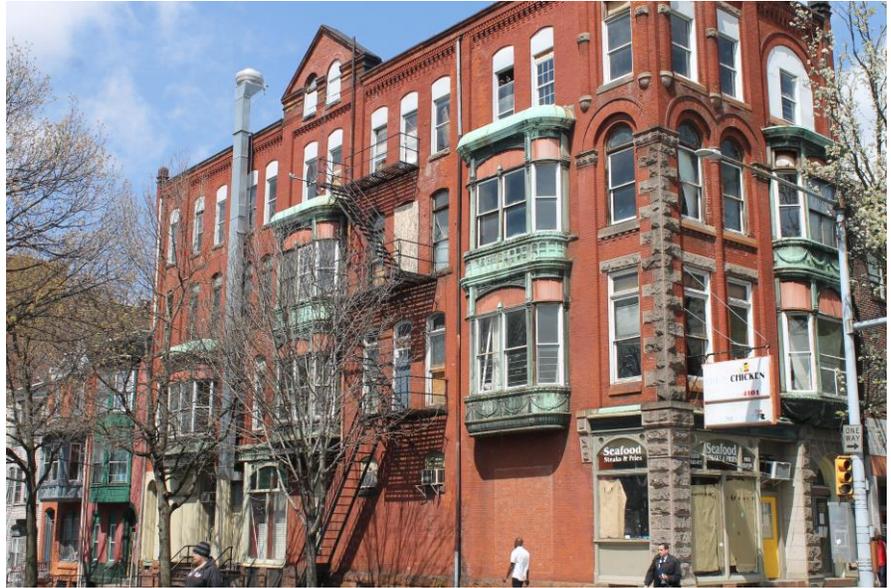
62 South 6th St

- Vacant Mixed use property
- Used for illegal parties
- Unsecured

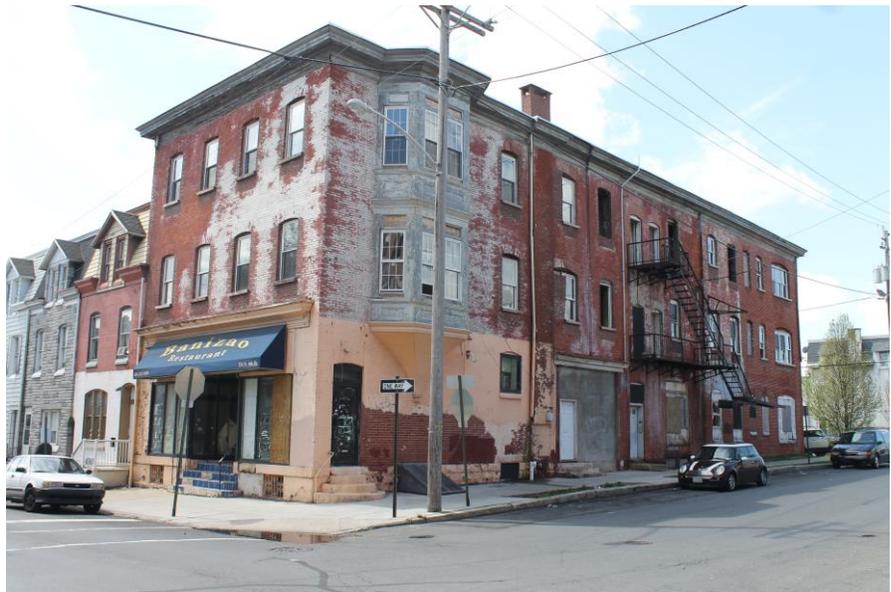
754 N 9th St

- Large three story, 1/2 block deep vacant structure
- Fire escape on both sides of building unknown condition.
- Unsecured on side opposite of Douglass St

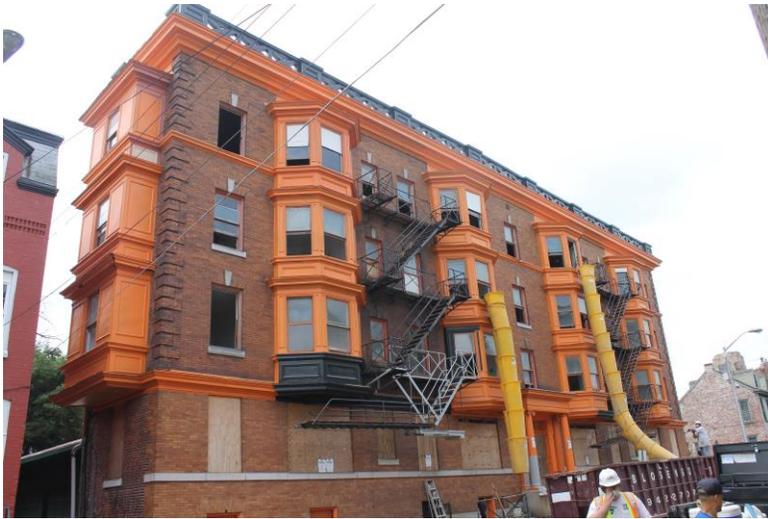
600 Block Elm St

- Large 4 Story Multiple Occupancy
- Vacant for sometime
- Currently undergoing renovations
- All windows are open on upper floors

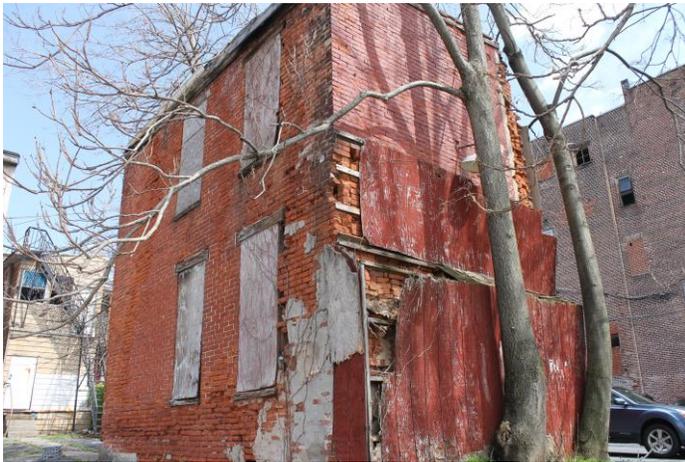
Rear 932 Penn St

OFF CHERRY ST

ALL WINDOWS BOARDED

ENTRANCE CAN BE FROM REAR CORNER THROUGH HOLE

PORTIONS ARE COLLAPSING

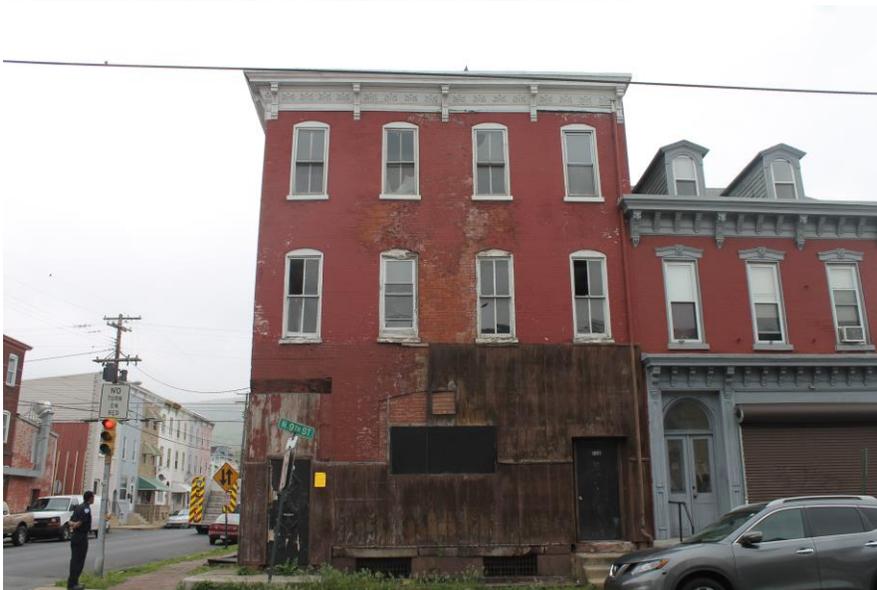
1057-59 N 9th Street

Large Multiple Occupancy currently vacant

First floor seems secured

Multiple windows are missing glass

Unknown interior condition

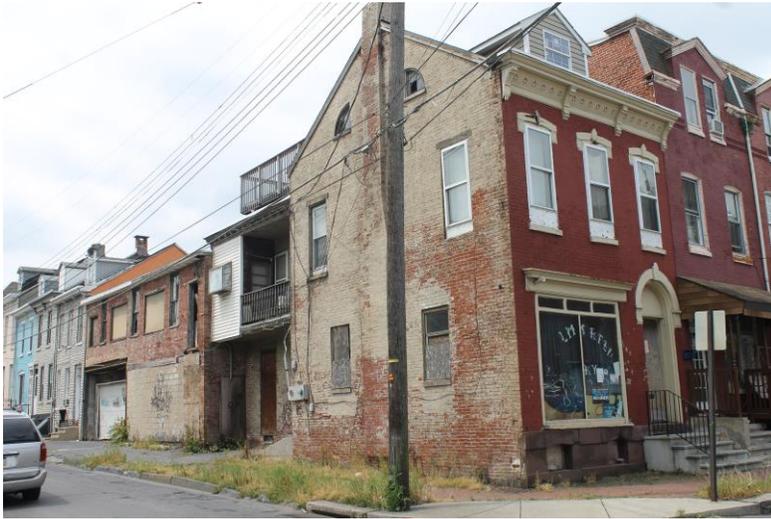
**SW Corner Reed &
Elm**
Increased dead load
added to second
floor roof.
Front dormer
appears to be
recently repaired
may be occupied.

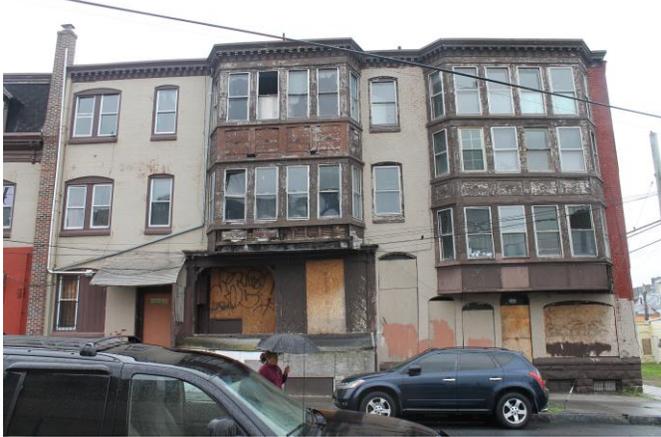
842 through 846 Elm St
Large multiple dwelling building, vacant,
first floor appears secured.
Unknown interior condition or layout, be
careful not to get disoriented.

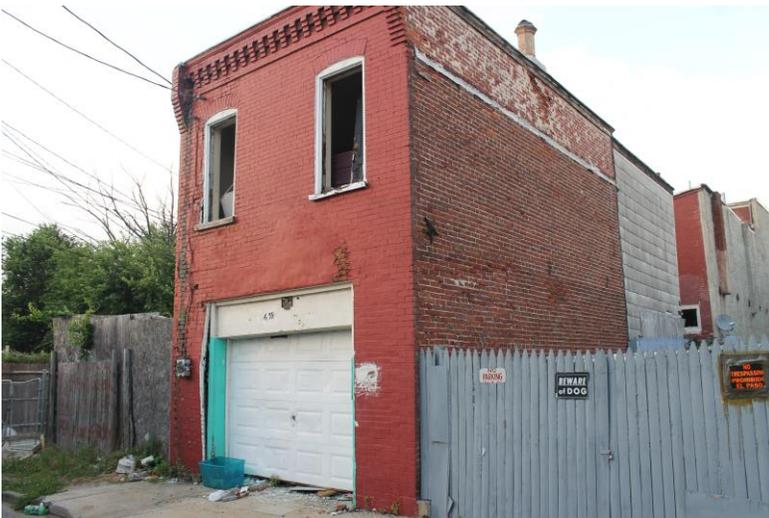
639 Miltimore St
Two story brick garage with rear two story wood
frame attachment.
Unsecured, front windows missing.
Notice brick wall aside of garage door bulging out.

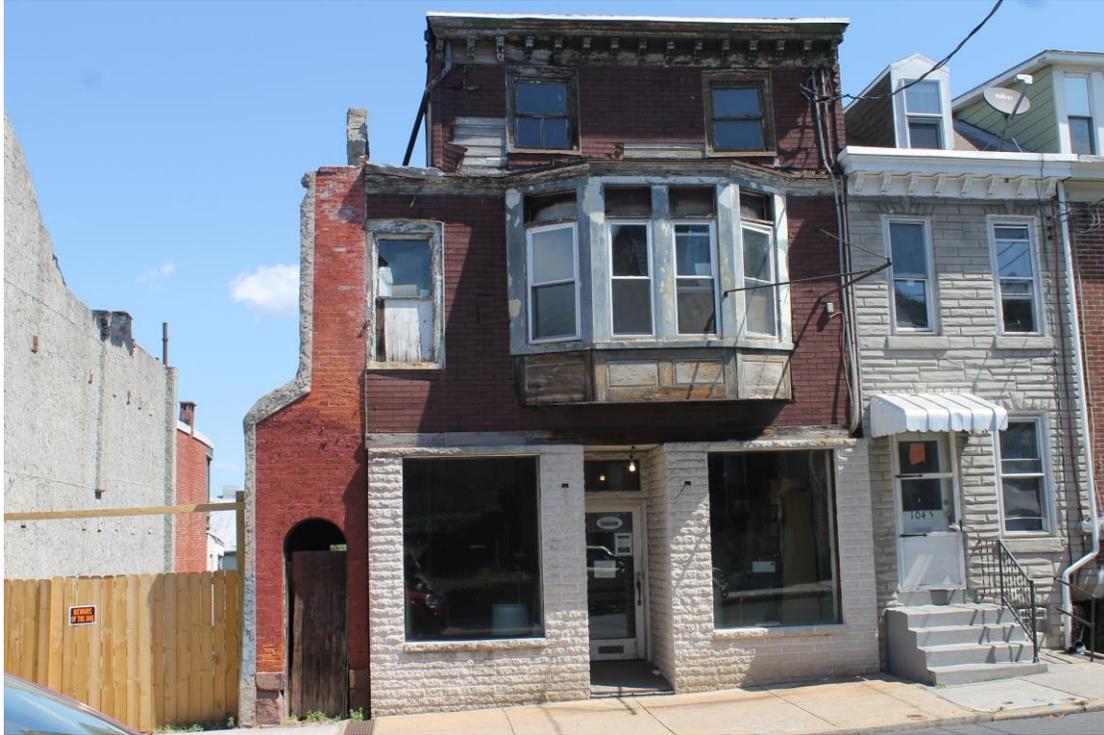
1043 Cotton St

This building has power but do not be fooled!

This building is being used as storage.

The floors are styled after a moat, the center is still in place but along every wall there is open space.

This is done on every floor so you will have rapid fire spread throughout. Only safe entry is through the front door as using a window will put you in the basement rather quickly.
