HAZARDOUS BUILDINGS BULLETIN

2nd Quarter 2016

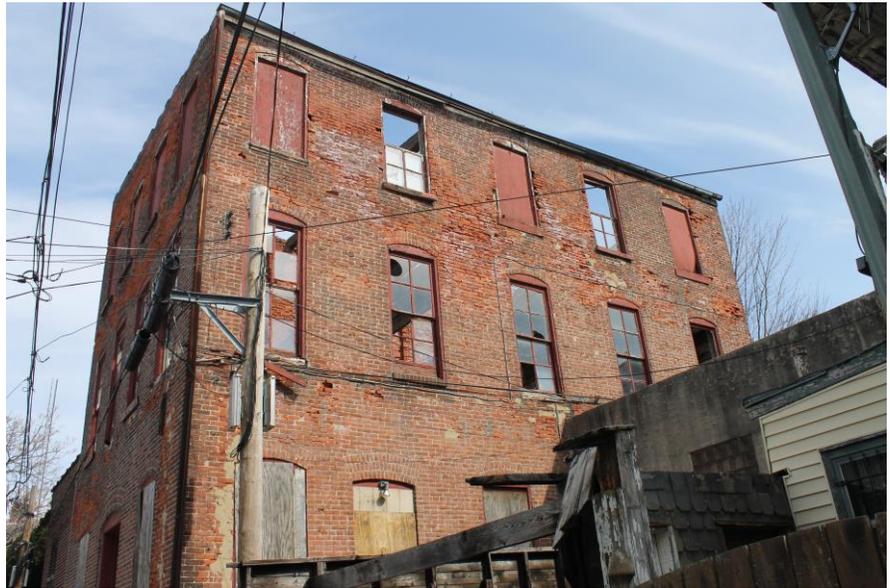
110 R Moss Street

- No roof, second or third floor.
- Access from ally to the rear of 101 N 9th St .
- Property is placarded as condemned.

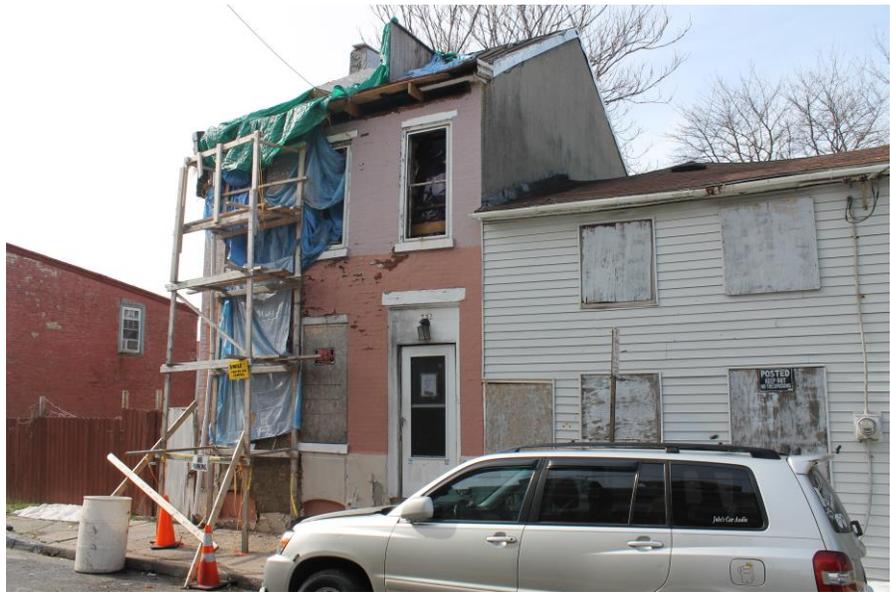
332 Cedar Street

- Dormer is collapsed into roof.
- Tarps in place for sometime, unsure what is underneath.

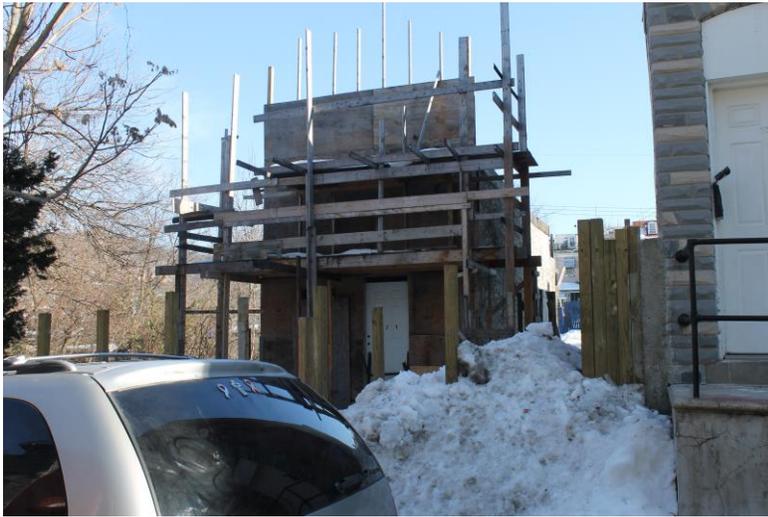
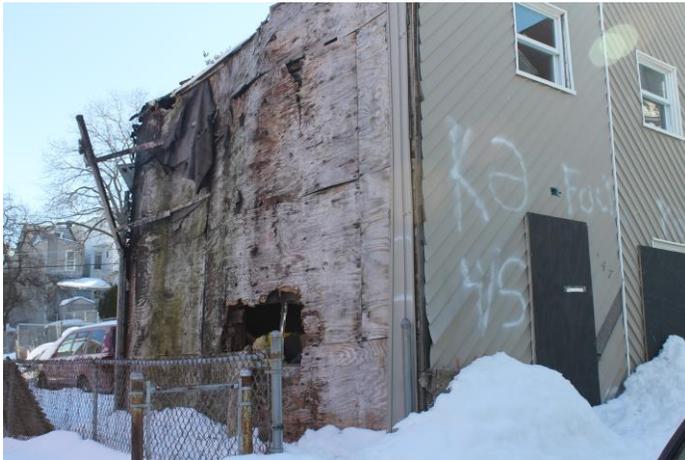
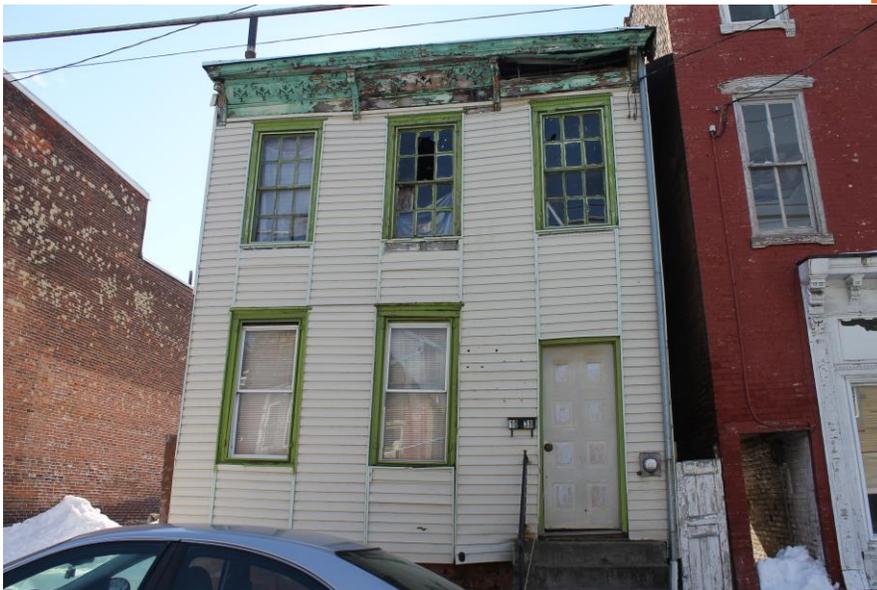
500 Block Maple St

- 527 Has 2x4 as scaffolding covering second floor front wall in place.
- 547 and 549 are semi's with 547 having a large hole in the B side wall, properties are unsecured.
- Properties can be considered abandoned. Use judgement as these could be considered exterior operations only.

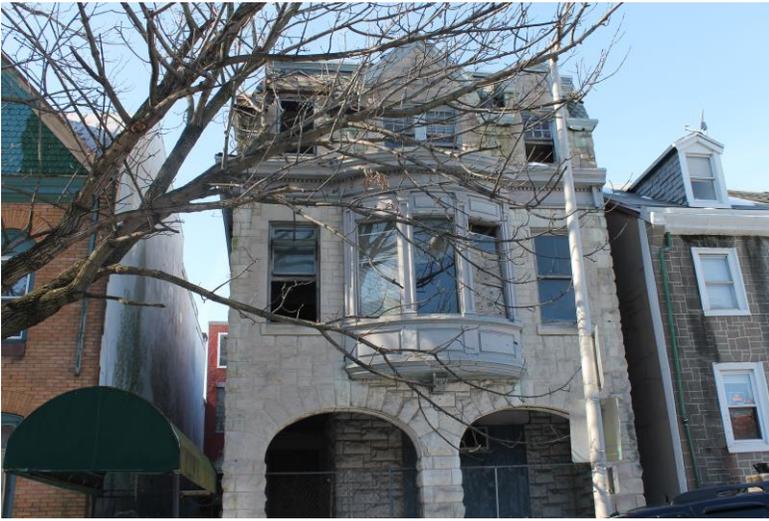
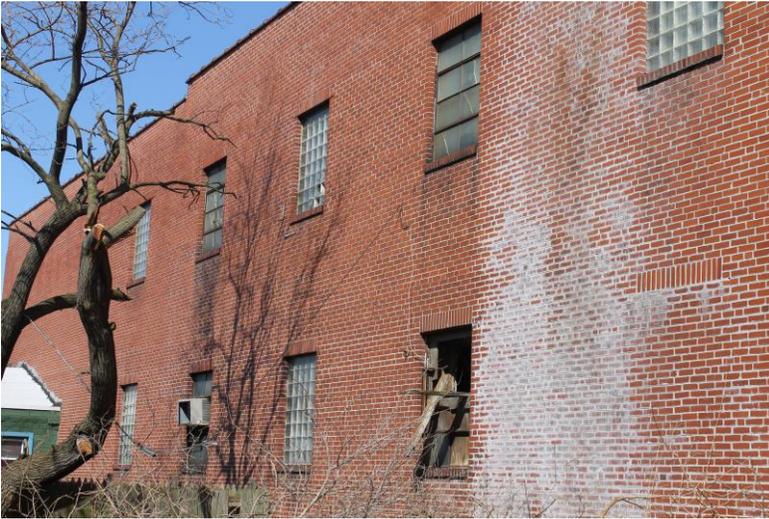
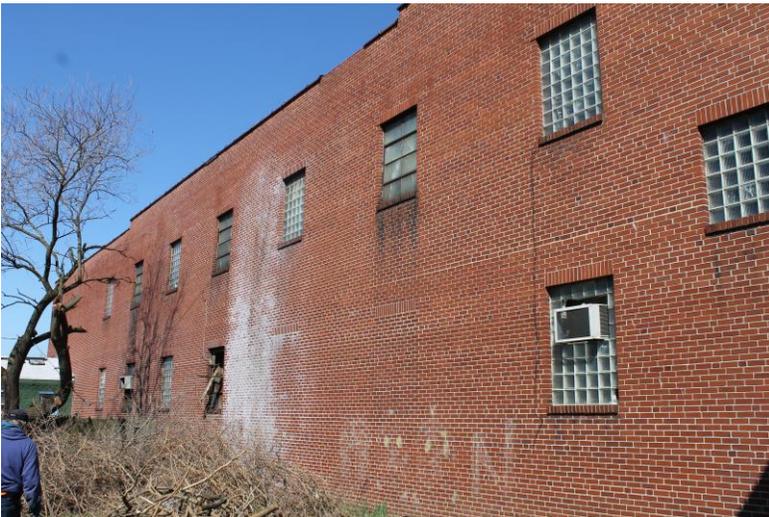
124 N 4th

“Stand alone” dwelling that was once residential and has had a 2 story warehouse added onto the rear that stretches to Rose Street. This building is unsecured. The area has had its fair share of nuisance fires. Windows are broken out and structural stability is unknown at this time.

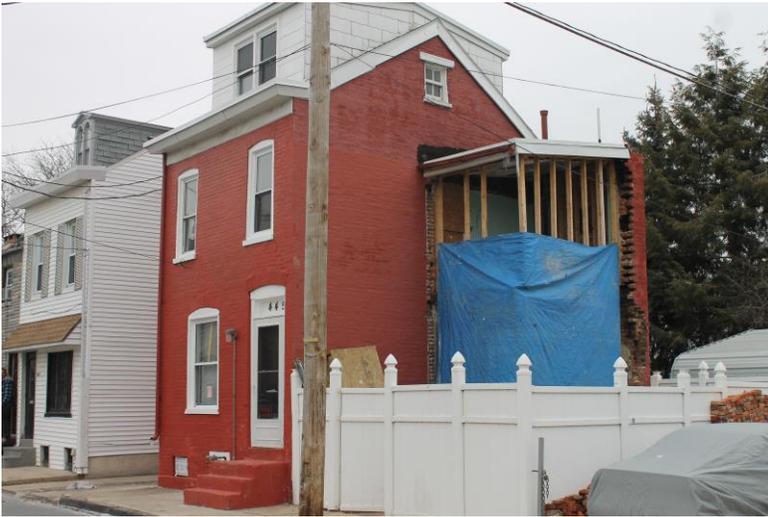
445 MINOR ST.
ADDITION BIRCK WORK
HAS COLLAPSED AND
ROOF IS BEING HELD
UP BY 2X4 WITH A TARP
COVER. IN THE
PROCESS OF REPAIR?

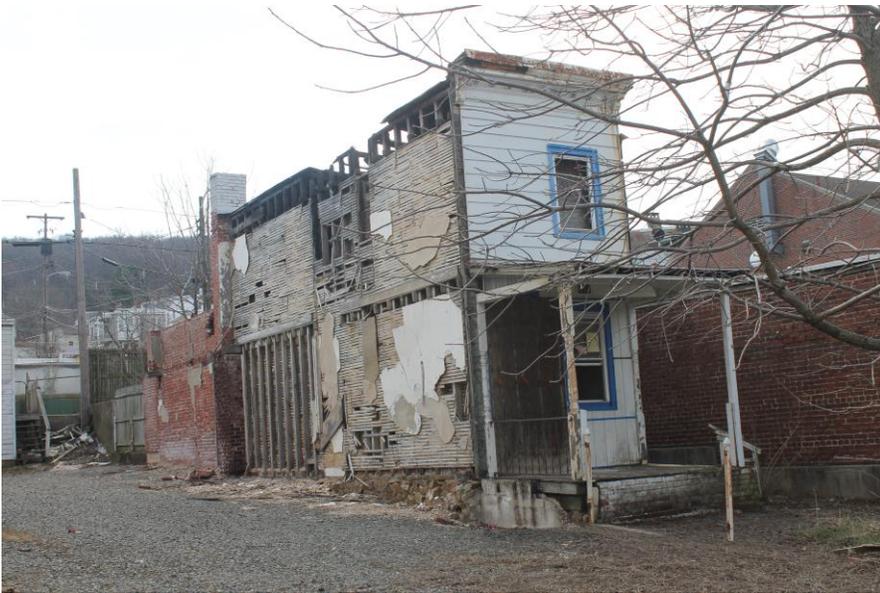
1822 Cotton Street

- Perfect example of demolition of one side of a semi.
- Portions of roof missing.
- Structural stability unknown.
- Exterior operations should be considered.

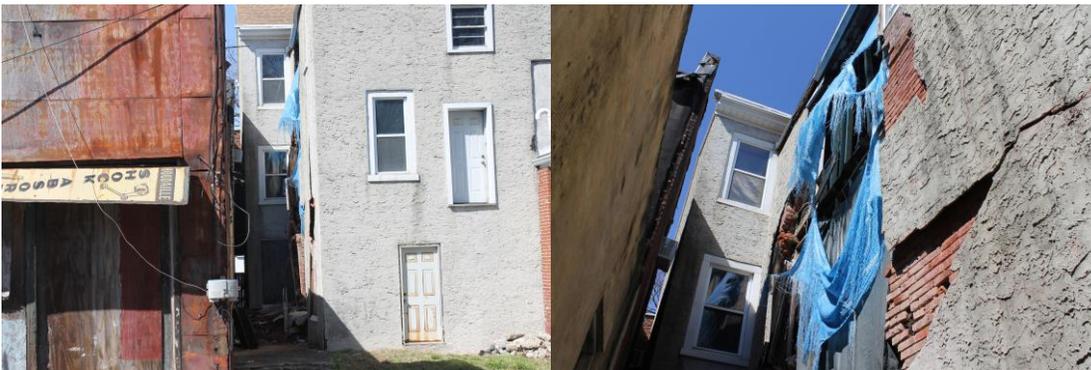
121 N 3rd Street: Note Exterior wall to rear of baker's alley is bowed out and collapsing. Use caution when accessing through baker's alley even in a non-fire condition.

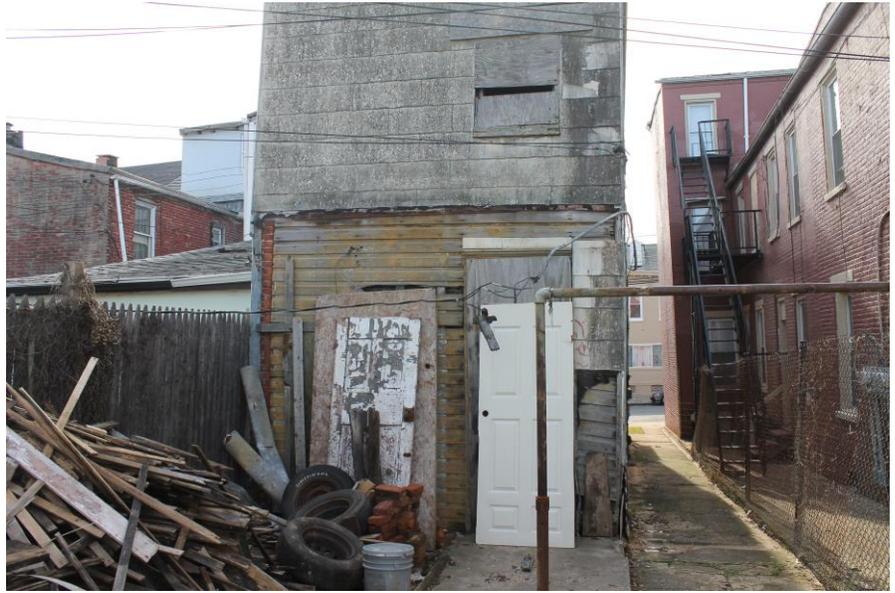
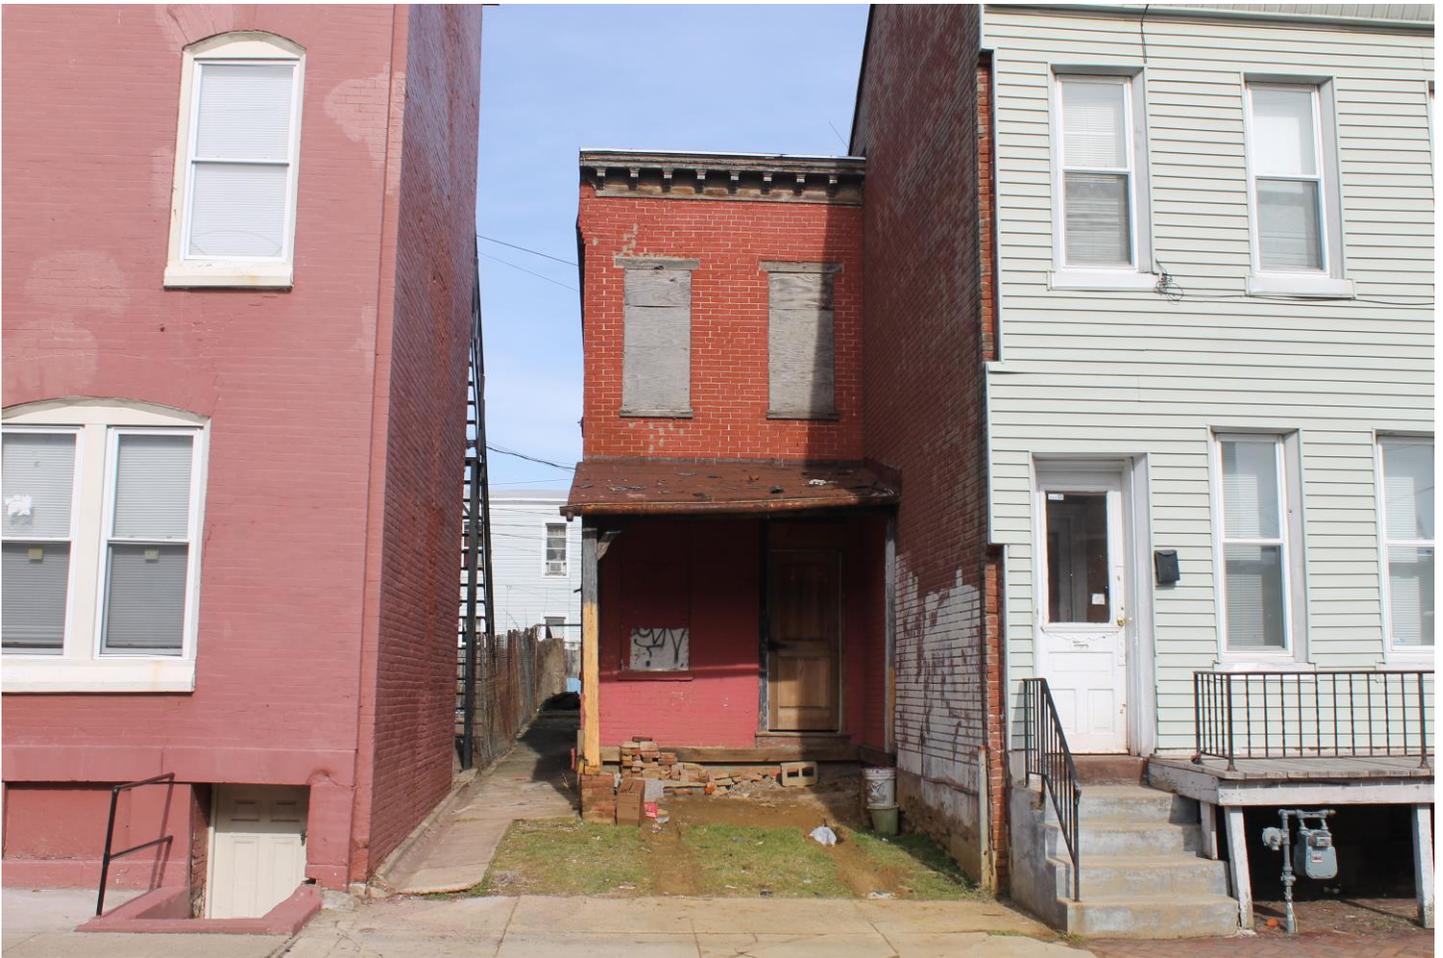
833 Green Street

Building appears to be leaning towards the alley.

Building is boarded unknown how secure it is.

Unknown on interior condition.
