SUPPLEMENTAL ENVIRONMENTAL IMPACT ASSESSMENT  
MONTAGE CAY  
ABACO

MINISTRY OF THE ENVIRONMENT AND HOUSING  
DEPARTMENT OF ENVIRONMENTAL PLANNING AND PROTECTION

APRIL 2021

SUPPLEMENTAL ENVIRONMENTAL IMPACT ASSESSMENT  
MONTAGE CAY  
ABACO  
THE BAHAMAS

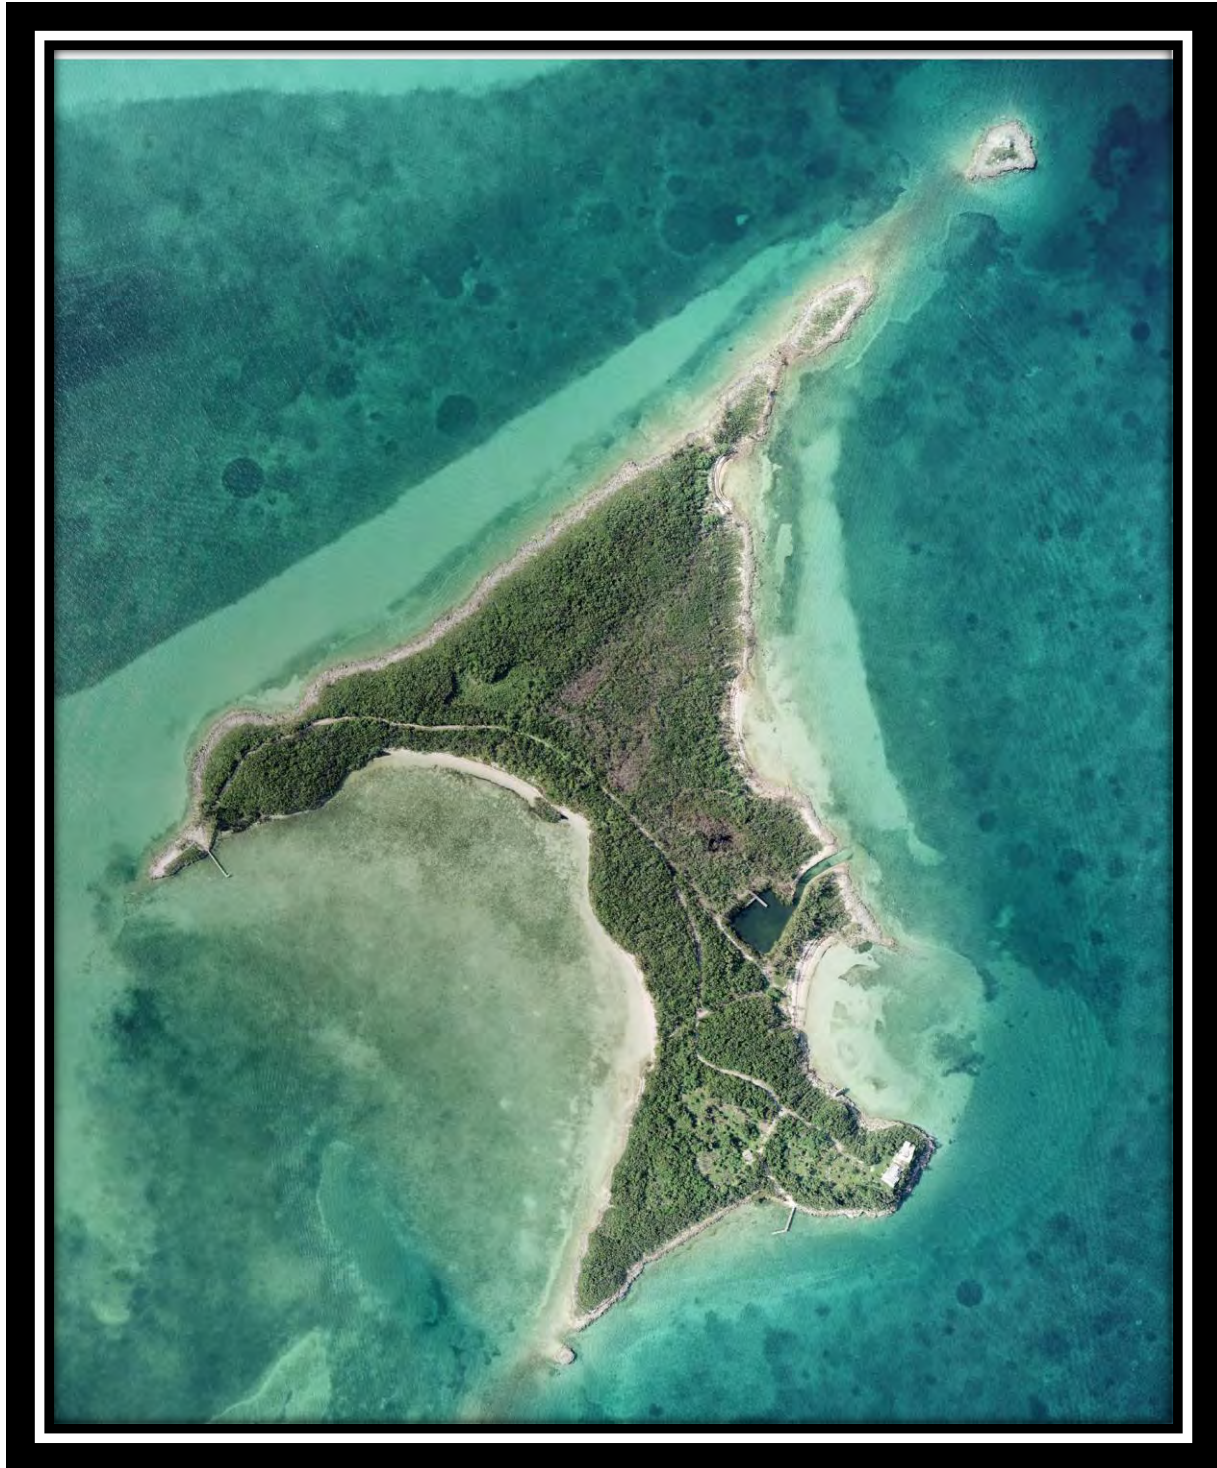
Figure 4. 2: Matt Lowe Cay Circa 2002

Prior to the Development commencing in 2002 the island was unoccupied save for a small marina and a single-family residence and support structure.

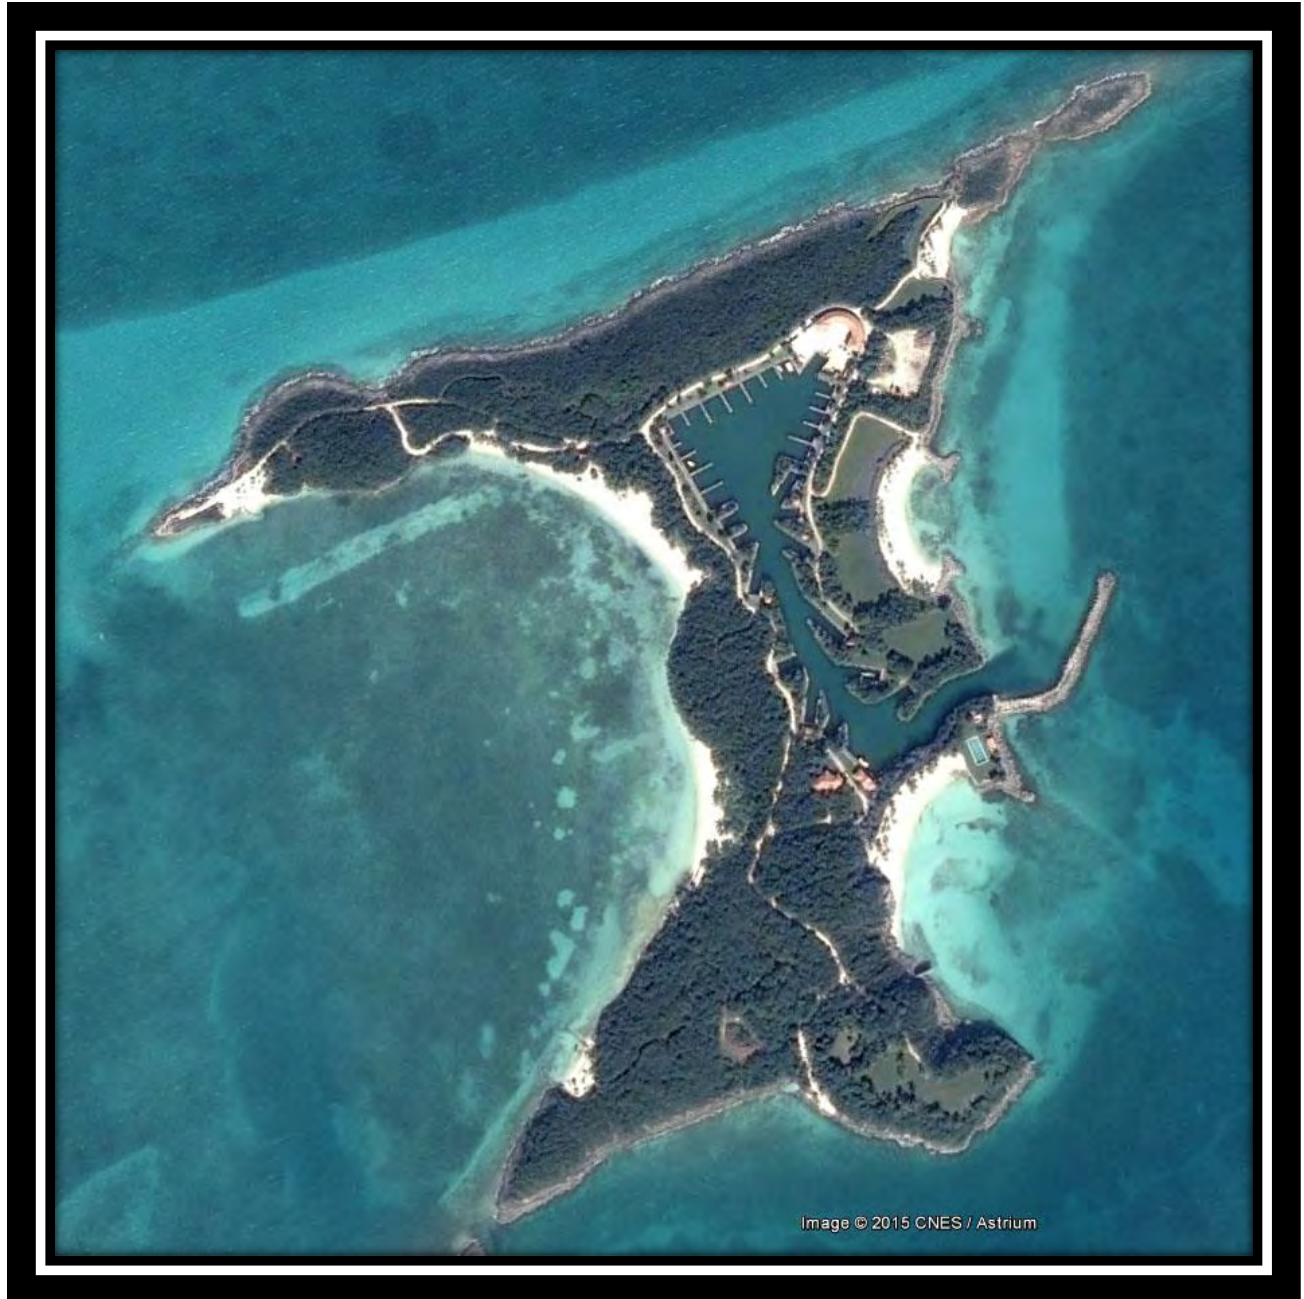
Figure 4. 3: Matt Lowe Cay 2015

Following the commencement of construction and development in 2002 the marina was excavated and developed together with infrastructural development of utilities, beach improvements and terrestrial vertical construction.

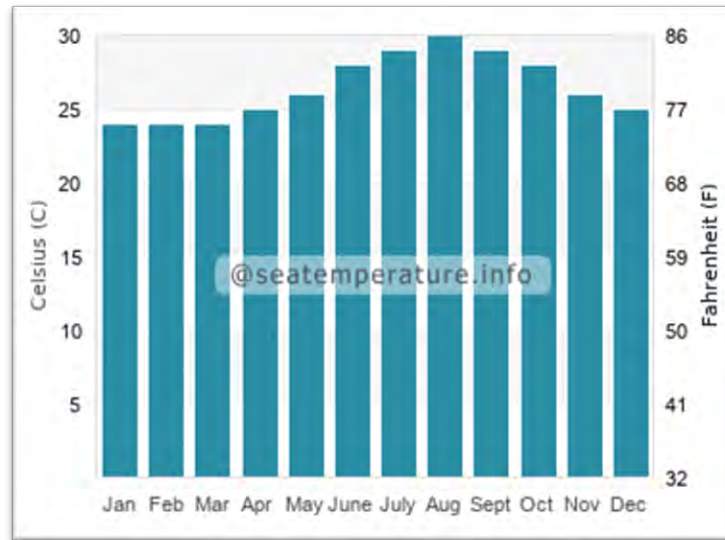
Figure 4. 5: Sea Surface Temperatures

Sea surface temperature normally varies between 74°F in February and 83°F in August. The following table depicts average monthly sea surface temperatures for Abaco.

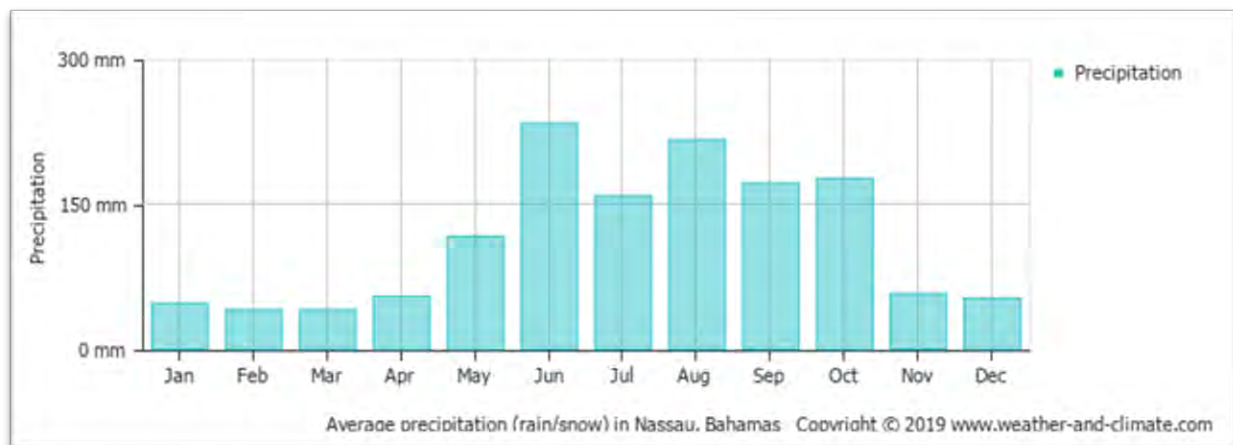
Figure 4. 6: Annual Average Rainfall

The following Figure 4.6 depicts average monthly rainfall that can be expected for Abaco (there is no specific data available for Matt Lowe Cay).

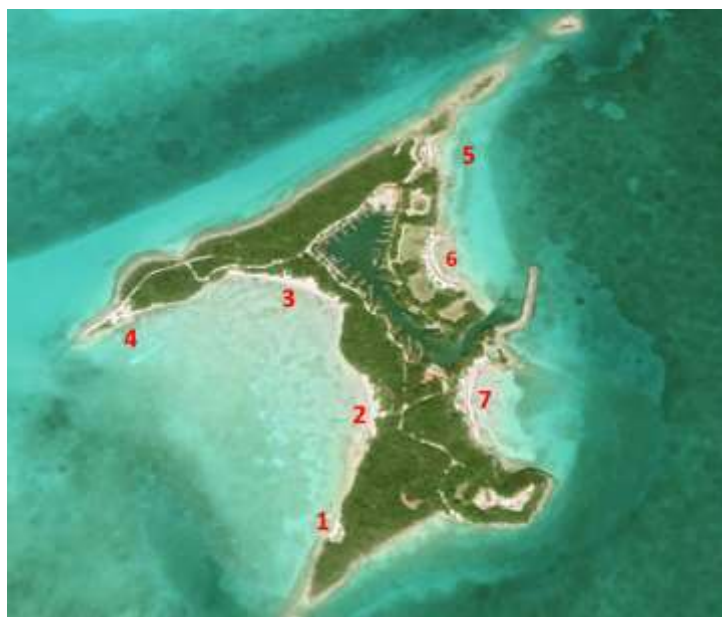
**Figure 2:** Location of Beaches at Montage Cay

Beach	Location	Description
1	Western shoreline (South)	Man-made beach
2	Western shoreline (Center towards South)	Man-made beach
3	Western shoreline (Center towards North)	Naturally occurring beach with enhancement in size of sand substrate.
4	Western shoreline (North)	Man-made beach
5	Eastern shoreline (North)	Naturally occurring beach with minimal enhancement.
6	Eastern shoreline (Center towards North)	Naturally occurring seasonal beach that was enhanced by the inclusion of breakwaters
7	Eastern shoreline (South)	Naturally occurring beach with minimal enhancement.

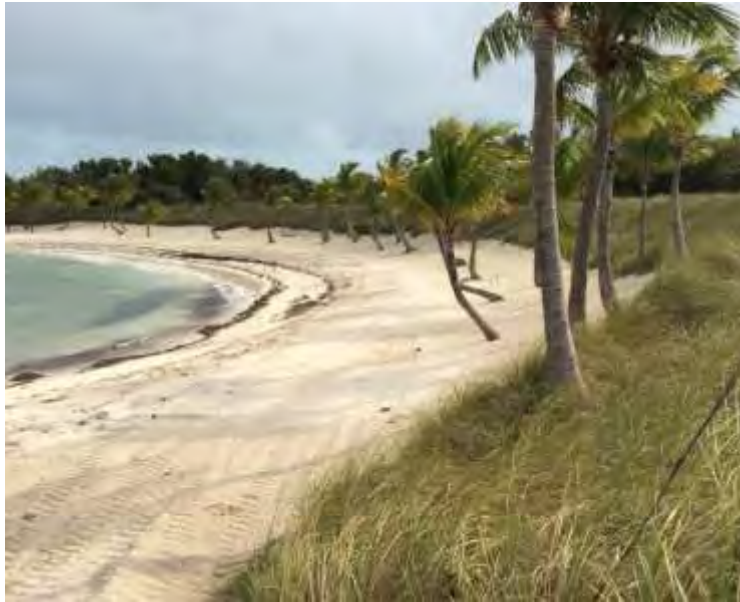
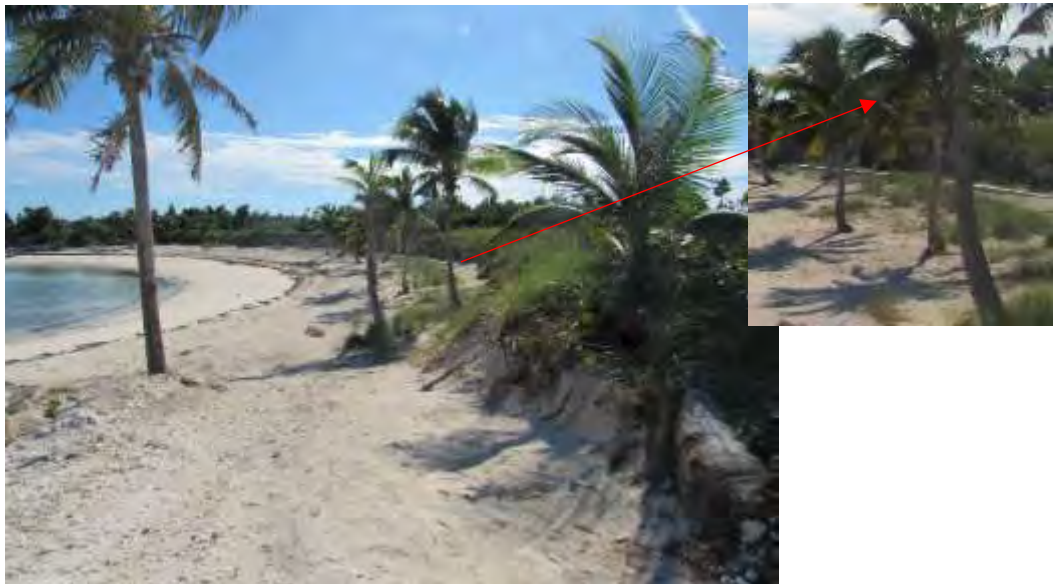
Changes to beach strand vegetation from the 2015 survey included erosion and loss of individuals of Coconut palms. Erosion was observed at Beach #6, where a retaining wall previously covered with sand and vegetation could be seen exposed in the 2020 survey.

**Photo 1:** Beach #6 (2015)

**Photo 2:** Beach #6 (2020)

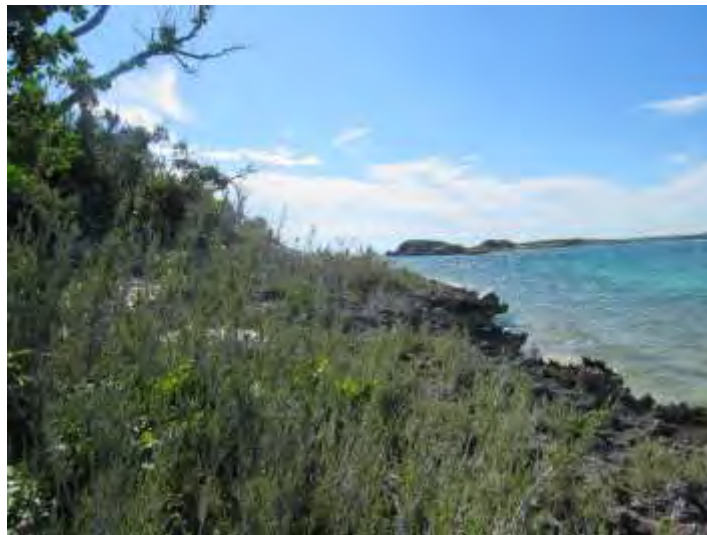
*Rhachicallis americana* shrubland (RAS) is present as a thin band averaging three meters wide, along the entire northern and southern coastline of the island. It was also present on the extreme Southwestern and North-eastern peninsulas of the site. It averaged ten meters in width at these locations and is subject to complete wind and salt spray. Vegetation is less than one meter in height in this plant community. *Rhachicallis americana* is the most common species. Other species are present in lesser quantity and include buttonwood (*Conocarpus erectus*), sea purslane (*Sesuvium portulacastrum*) and occasional species common in beach strand and dry broad-leaf evergreen formation vegetation.

**Photo 3:** *Rhachicallis americana* Shrubland along south western shoreline  
(view facing South - 2020)

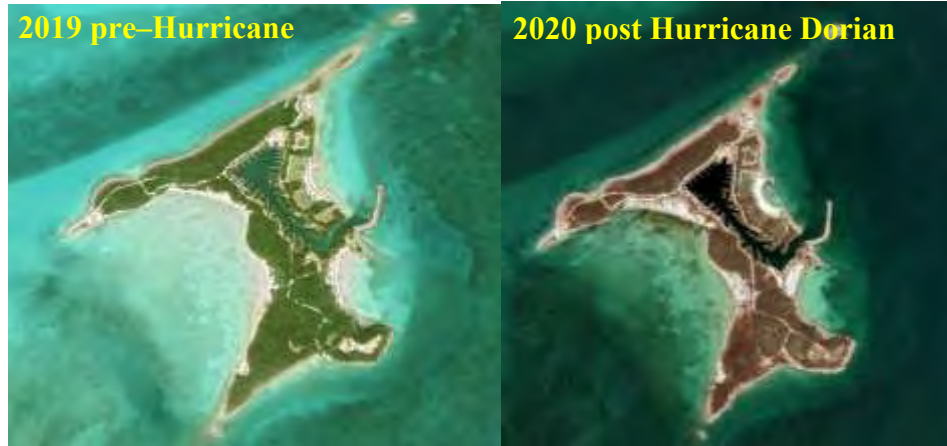
Most of the northern, western and southern interior upland areas on the site are represented by naturally occurring dry broad-leaved evergreen forest (DBEF). The vegetation height in these areas averaged 15-20 feet in height at the time of the investigation however the 2015 study recorded the height at 20-25 feet. The difference in height is likely due to top die back of trees resulting from wind and or salt damage during Hurricane Dorian. Photo 4 below are aerial images of the island in 2019 prior to Hurricane Dorian with green vegetation and 2020 post hurricane image which shows storm damaged vegetation.

**Photo 4:** Aerial image of Montage Cay years 2019 and 2020

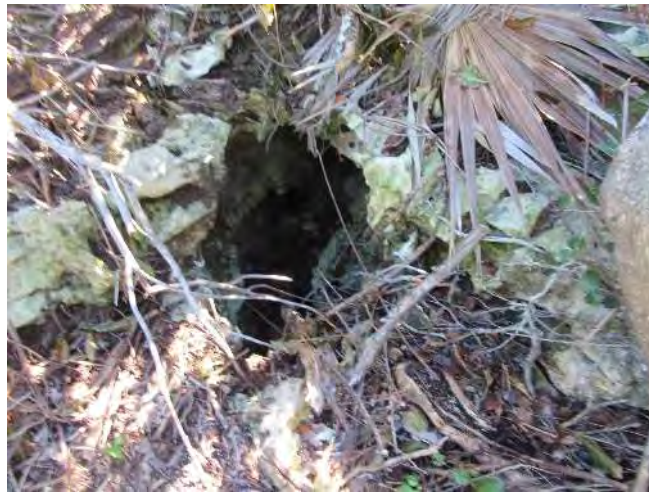
The porosity of the carbonate geology of the Bahamas allows for rapid infiltration of rainfall and surface runoff that dissolves the rock substrate creating characteristic sinkholes, caves and caverns (karst features). Karst features observed on the island include two (2) caves which are present within the dry broadleaf evergreen formations along the south eastern coast of the island and sinkholes within the DBEF vegetation type. Although no possible point of connection was observed between the two caves, based on the proximity of the locations, it is likely that these are one system with two openings connected underground.

**Photo 7:** Sinkhole in DBEF Montage Cay (2020)

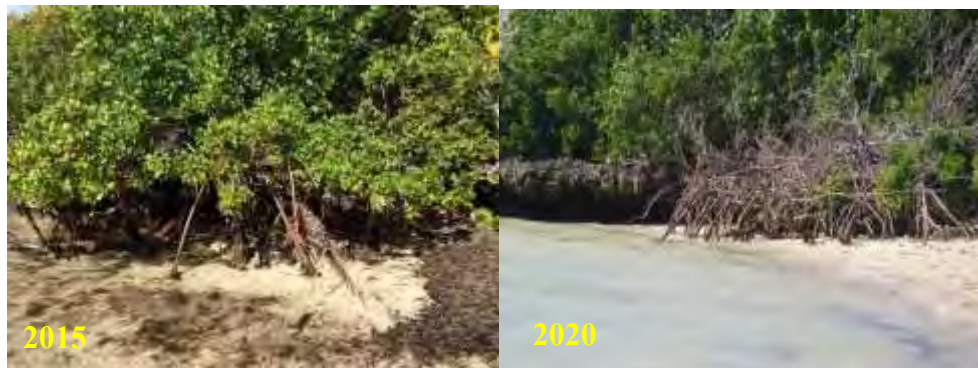
One small patch of *Rhizophora mangle* (Red Mangrove) that was observed along the Western shoreline immediately to the North of Beach #6 during the 2015 survey received substantial storm damage.

**Photo 9:** Red Mangrove patch along western shoreline of Montage Cay years 2015 and 2020

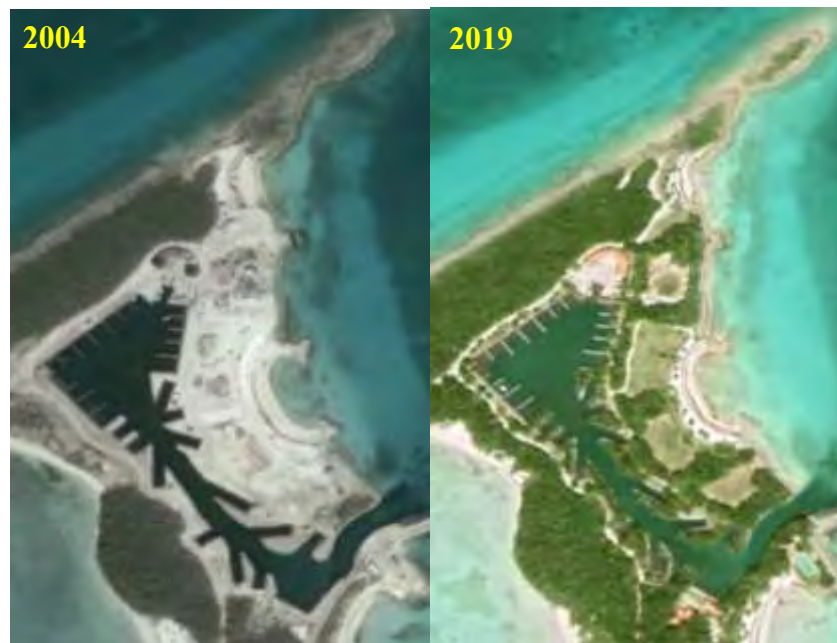
Human altered areas on the site includes structures, lawns, roads, a storage yard, landscaped areas and sections of disturbed vegetation. The entire area East of the marina was completely human altered. It was previously cleared and revegetated with a series of lawns separated by a buffer of native broadleaf vegetation. Photo 10 below are aerial images of the area in 2004 completely cleared and 2019 showing revegetation.

**Photo 10:** Aerial view of human altered areas years 2004 and 2019

DBEF was also present in areas to the East of the marina as buffer patches that were revegetated after the area was raised with dredge material during the marina construction (see photo 10). For the most part, vegetation in this area was similar to the naturally occurring DBEF. Several species such as Jamaican Caper (*Capparis cynophallophora*) were introduced that were not observed in other areas of natural vegetation on the site.

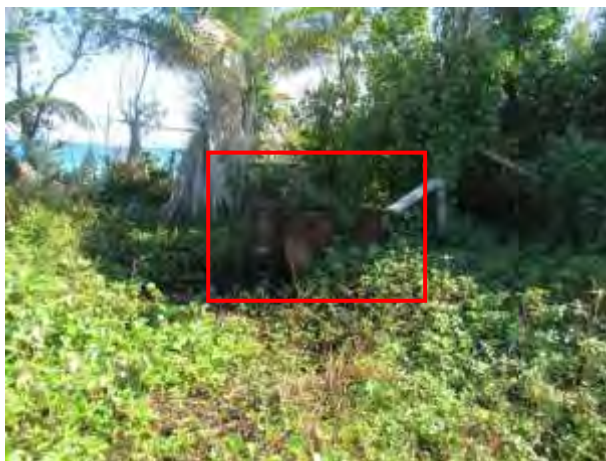
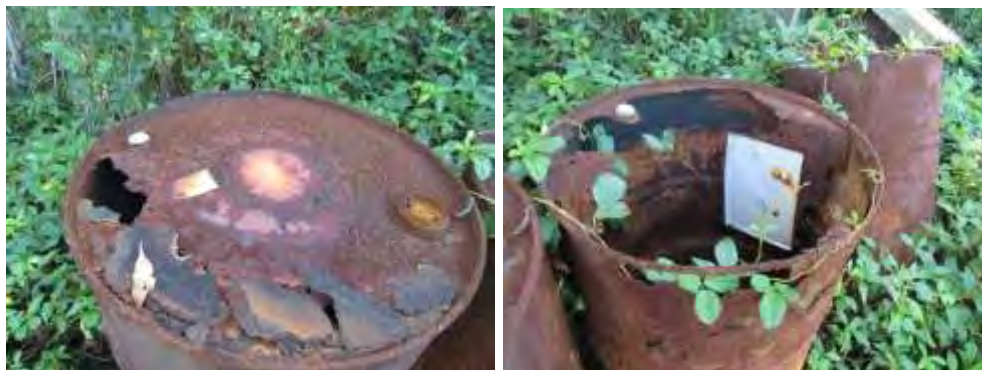
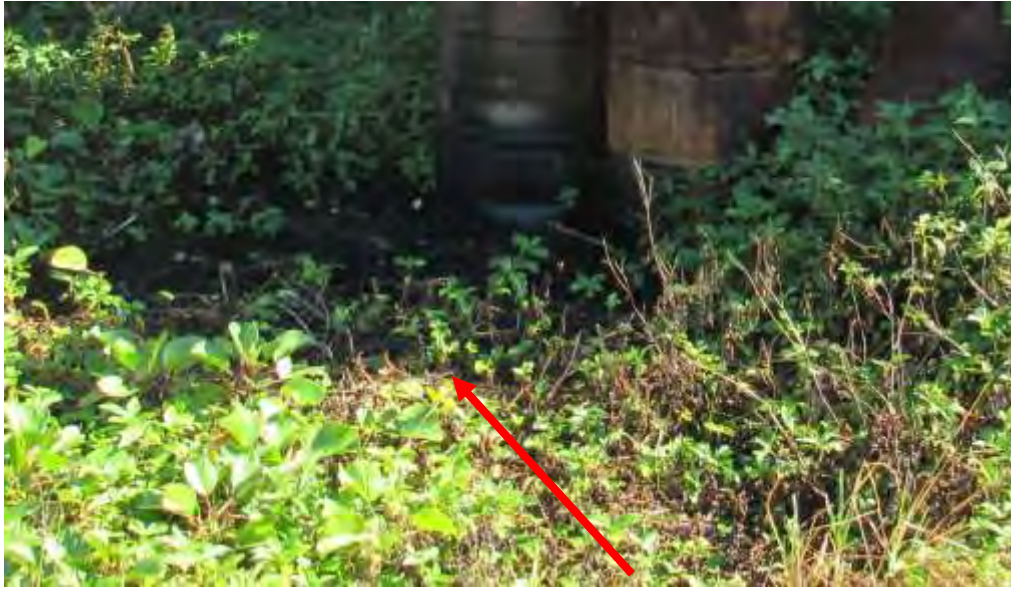
Three (3) 55gallon barrels with suspected hydrocarbon material is located in the human altered area within the maintenance yard. The barrels are in an advanced stage of corrosion and the contents are exposed. There is evidence that some material has leaked from one or more of the containers.

**Photo 20:** 55 gallon barrels with suspected hydrocarbon material

**Photo 21:** Corroded barrels with exposed material

**Photo 22:** Hydrocarbon-stained ground around 55 gal barrels

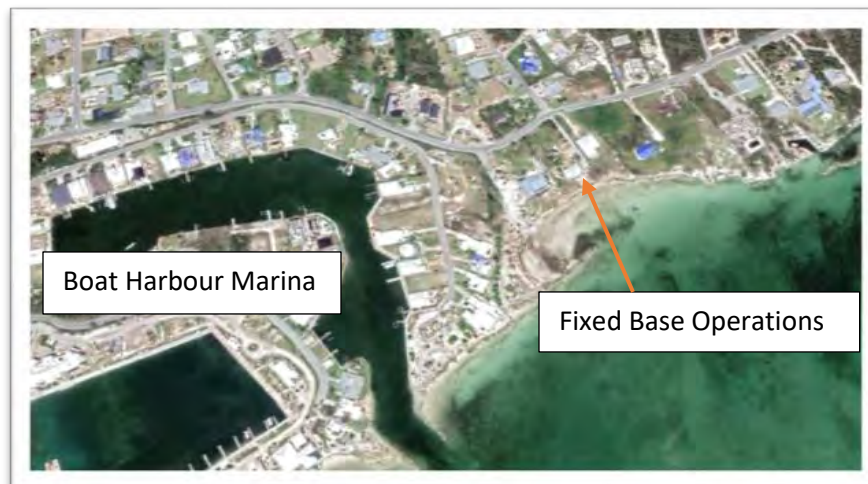
Sterling Global Financial as part of the continued development of the Montage Cay purchased a parcel of land on mainland Abaco within Marsh Harbour that is to serve as a Fixed Base Operations (FBO), site to facilitate guests, goods and services to and from Montage Cay.

The parcel is the former residence of Mr. Edison Key that was extensively damaged during the passage of Hurricane Dorian in September 2019.

**Figure 2 - Fixed Base Operations**  
(Image Courtesy of Google Earth)

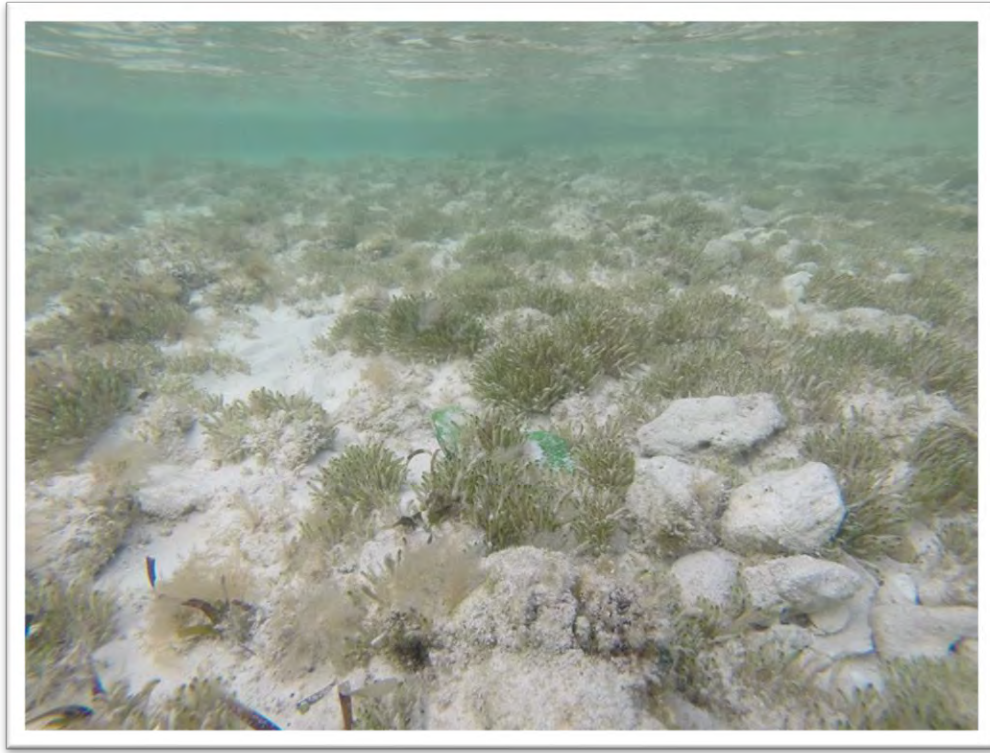
The benthos in front of the damaged dock in the survey area was previously dredged, but to what depth is unclear, as sediment probing was not conducted at the time of the survey. The area is filled in with sand and uncolonized by algae or invertebrates, but the outline of the area dredged can still be clearly seen in the surrounding rock and is visible in the U.A.V. photography.

**Figure 4 - Rock**

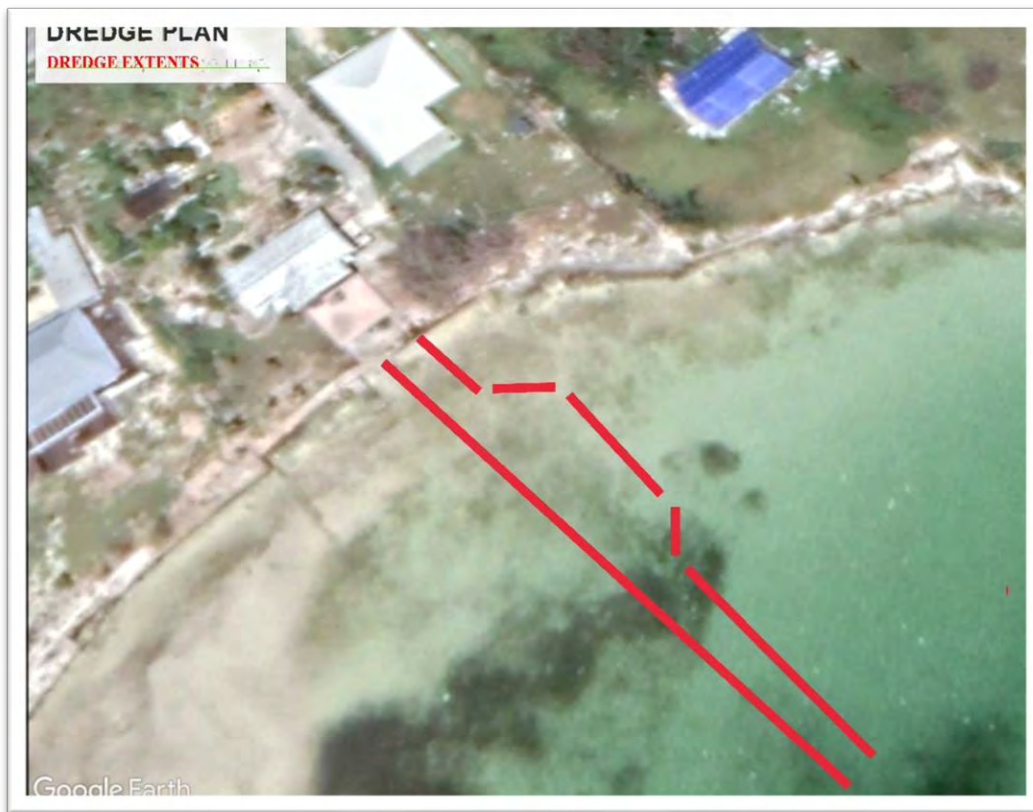
An approach channel will have to be dredged to a depth of six feet at mean low water (MLW) extending approximately one hundred and thirty feet beyond the end of the proposed dock on a bearing of 120°.

**Figure 6 - Dredge Extents**

Dredging will result in approximately 2100 cubic yards of spoil material that will be transported to Montage Cay for later re-use.

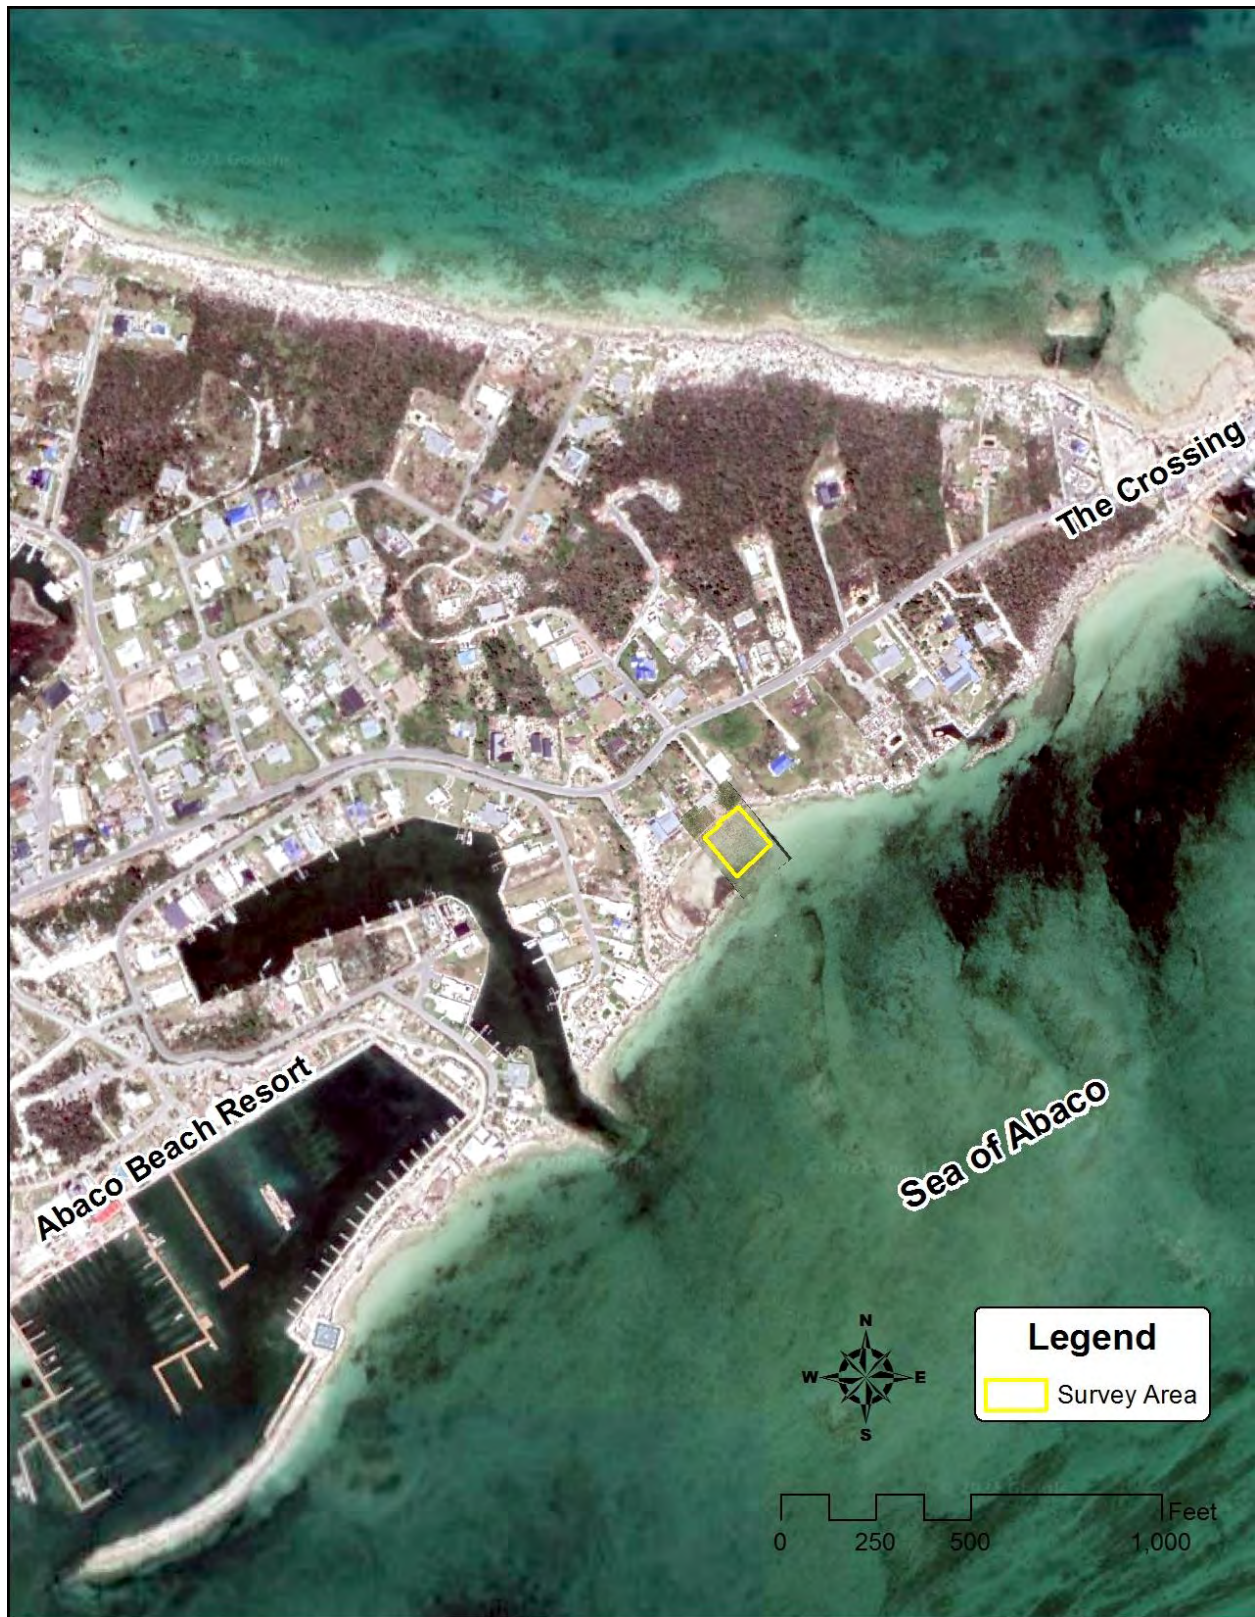
Figure 7 - Location of the survey area

A benthic survey was conducted for a small parcel of water along the southeastern side of Marsh Harbour, Abaco. The survey area is illustrated in **Figure 7**. The purpose of the investigation was to map benthic communities/cover types, determine species diversity, and identify the presence or absence of protected and invasive species.

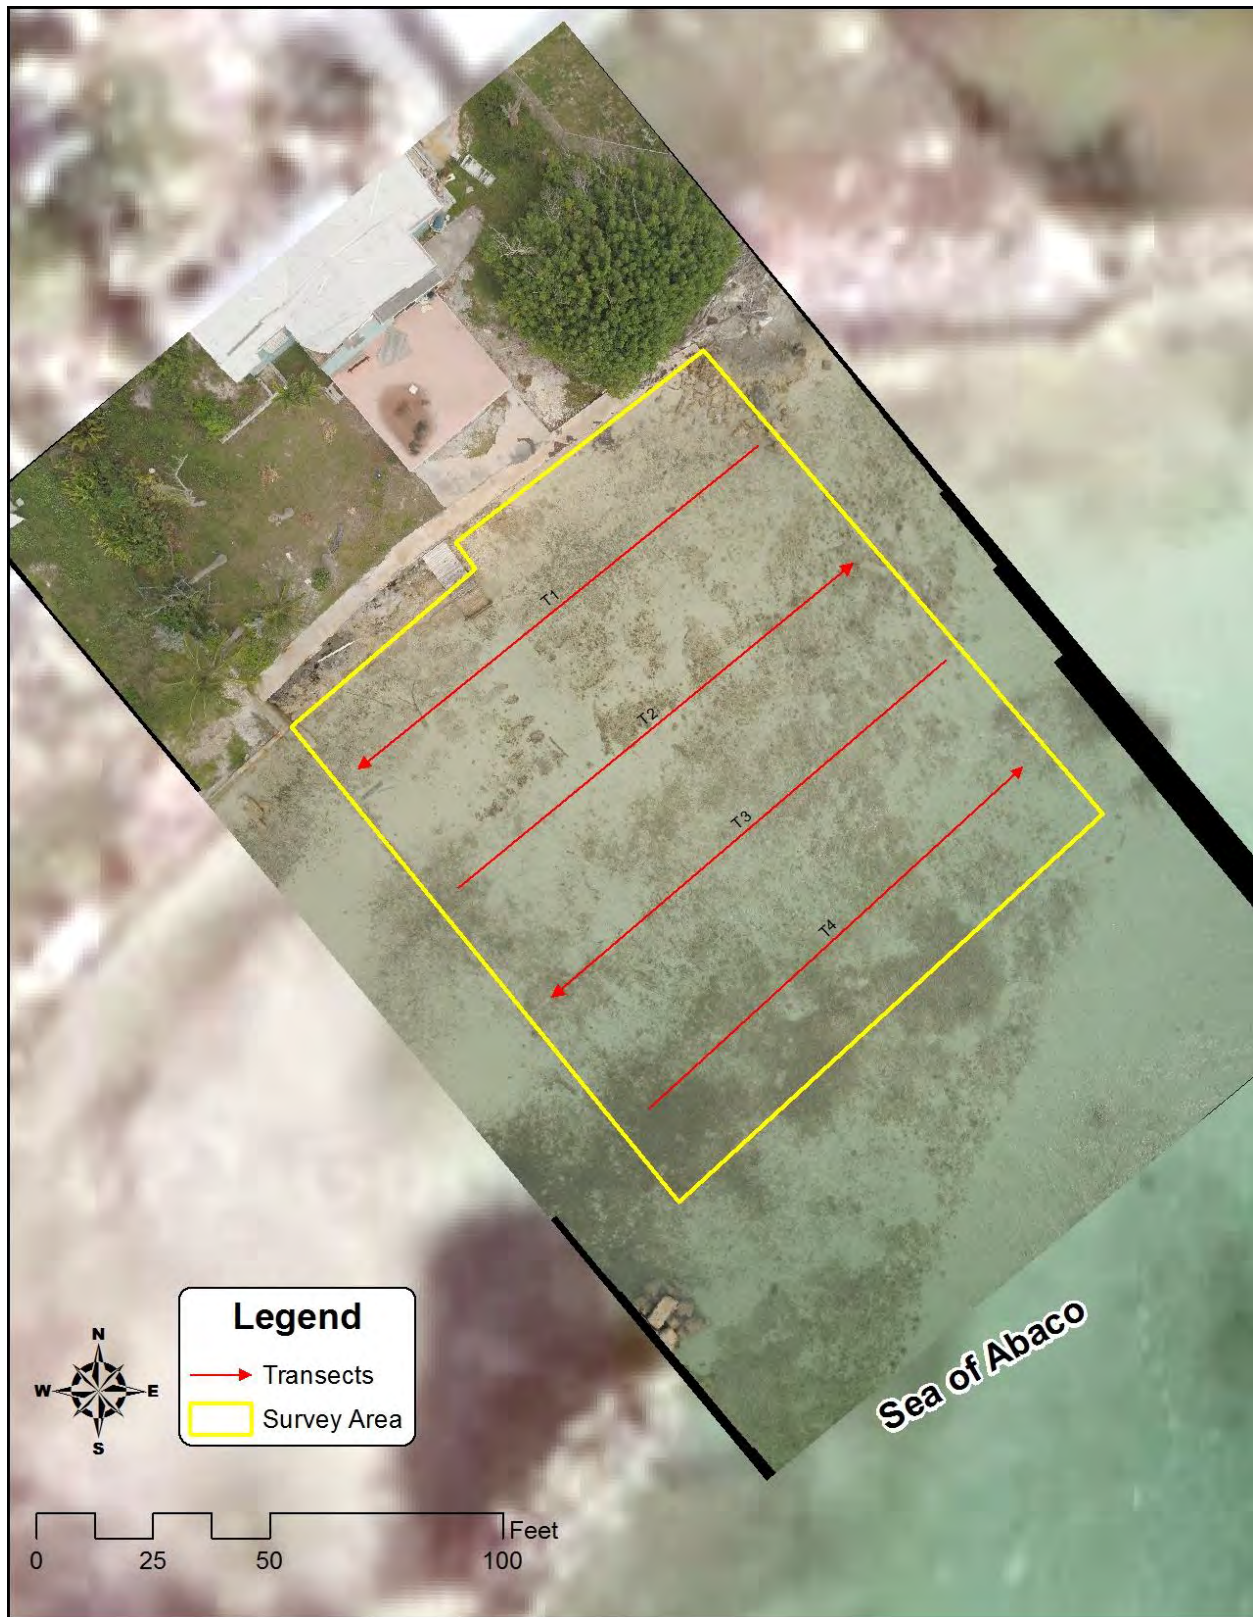
**Figure 8 - Transect locations and orientations**

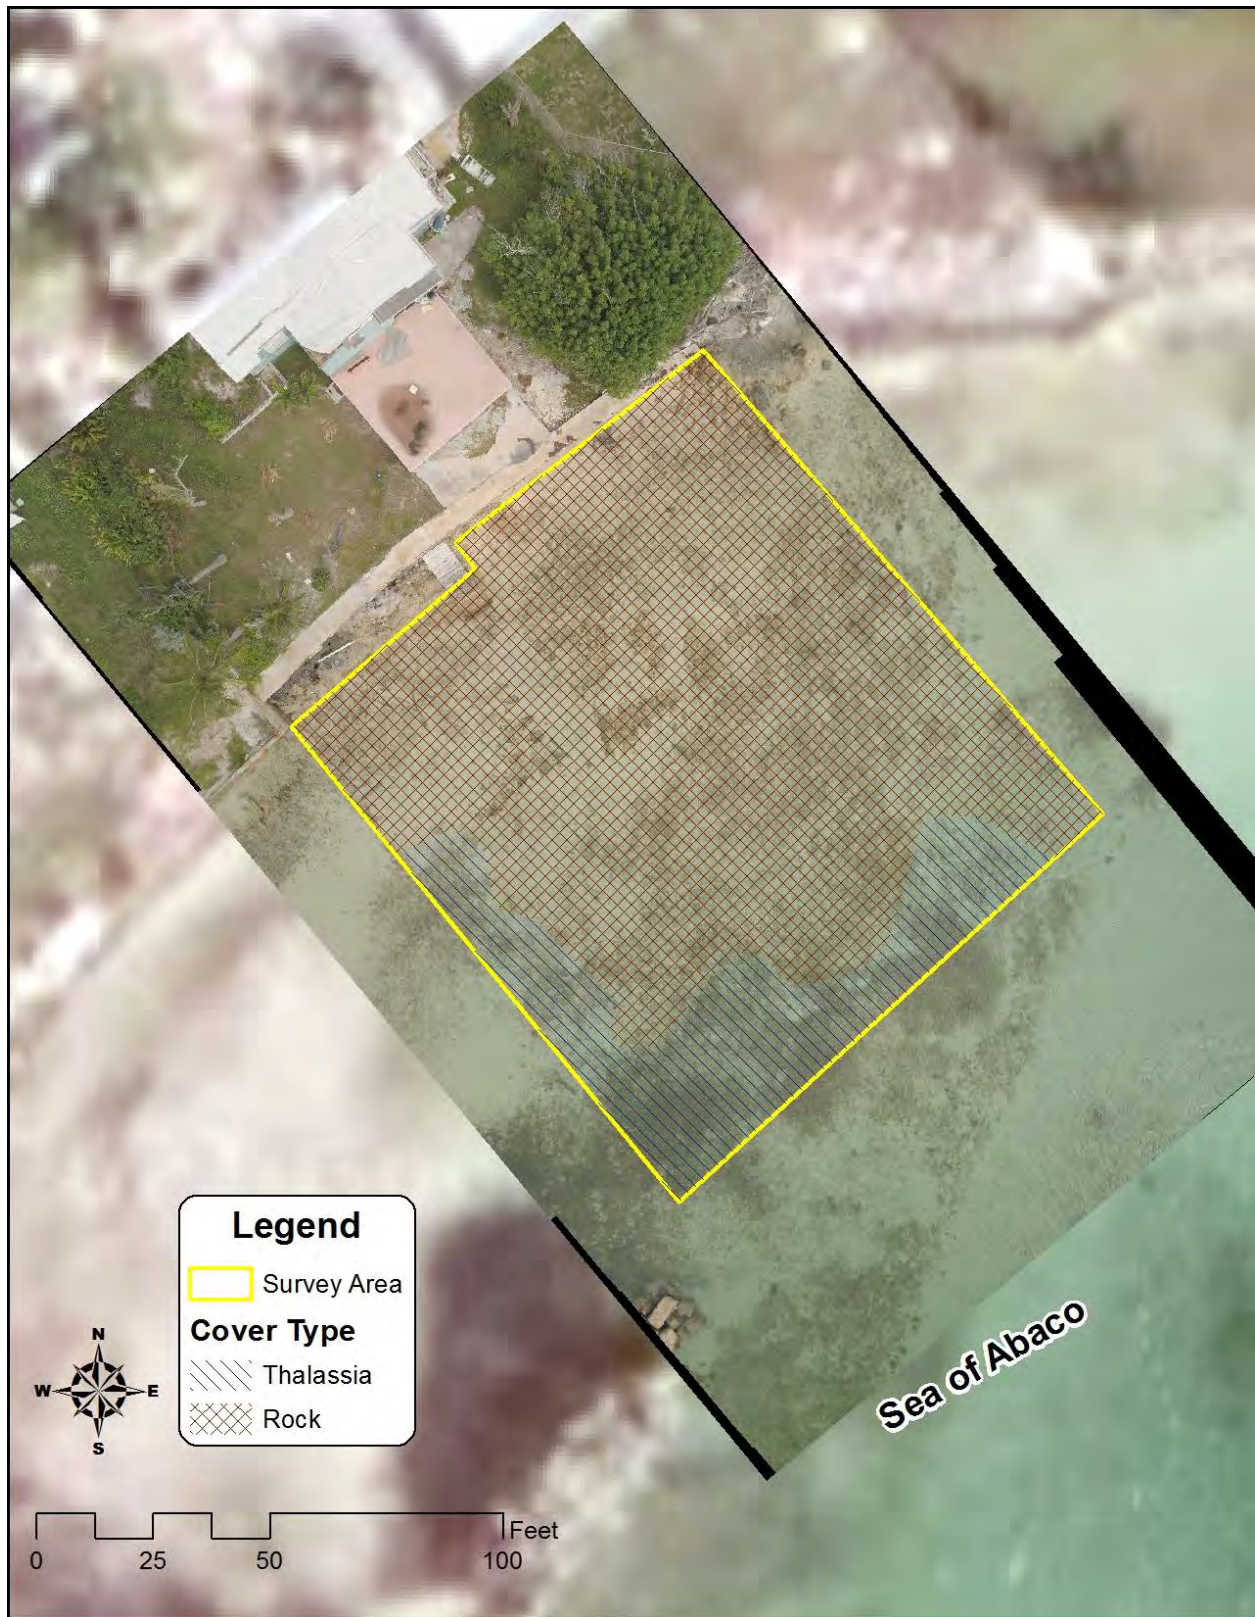
Figure 9 - Benthic cover types
