September 19, 2011

Re: Lake DeTurk Dam Inspection

Lake DeTurk Dam
 Ozark Fisheries
 1100 Ozark Fisheries Rd
 Stoutland, MO 65567

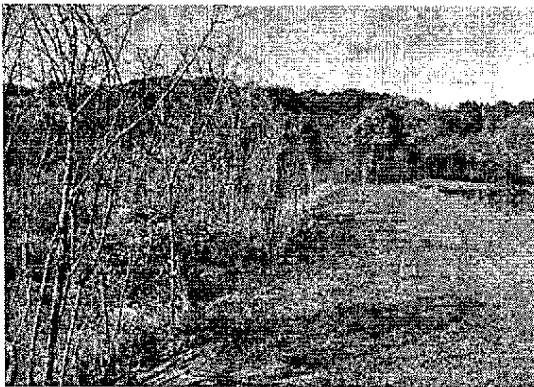
Trees and brush should not be permitted on embankment surfaces or in vegetated earth spillways. Extensive root systems can provide seepage paths for water. Trees that blow down or fall over can leave large holes in the embankment surface that will weaken the embankment and can lead to increased erosion. Brush obscures the surface limiting visual inspection, provides a haven for burrowing animals, and retards growth of grass vegetation. Tree and brush growth adjacent to concrete walls and structures may

Figure 1 – Trees and brush on dam embankment

eventually cause damage to the concrete and should be removed.

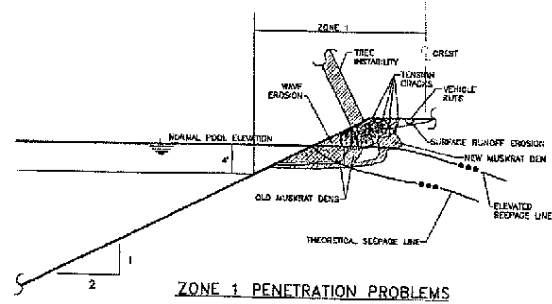
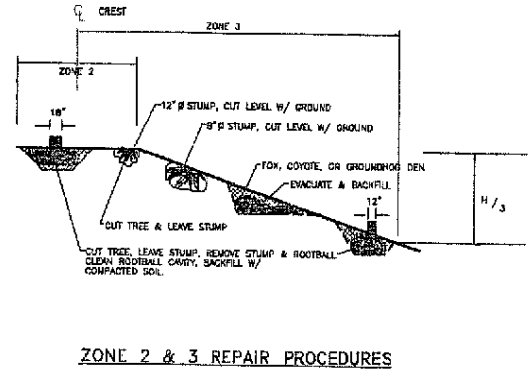
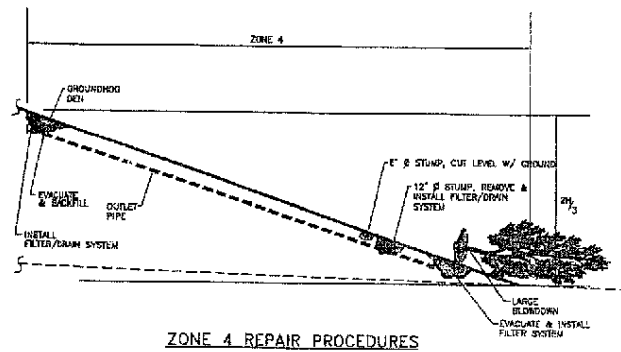
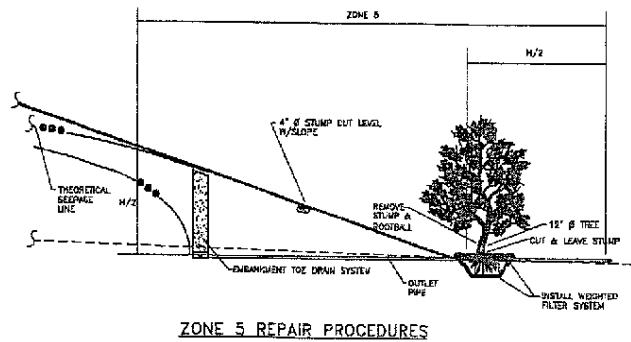
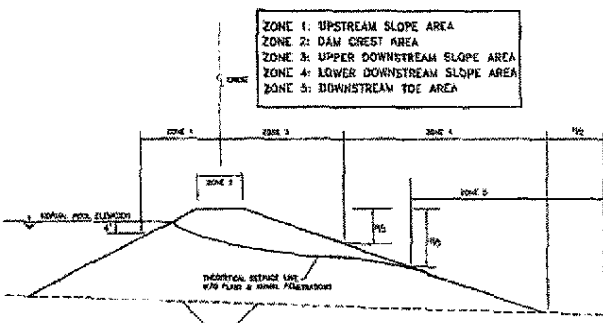
Figure 2 – Embankment Zones Related to Tree Removal

Figure 3 – Repair Procedures for Embankment Zones

The following guidelines are recommended when removing trees from dams (see Figures 2 and 3):

Zone 2: Cut trees in overlap area of Zone 2 and Zone 3 having stump diameters of twelve inches or less flush with the ground and treat the stump with a waterproof sealant to prolong stump decay.

Zone 3: Cut trees having stump diameters of about eight inches and less level with the ground and treat the stump with a waterproof sealant to prolong stump and rootball decay.

Zone 4: Cut all trees having stump diameters of six inches or less flush with the ground and treat the stump with a waterproof sealant to prolong stump and rootball decay.

Zone 5: Cut all trees having stump diameters of about four inches and smaller flush with the ground and treat the stump to prolong stump and rootball decay.

Install a major embankment toe drain or subdrain system to lower the phreatic surface, filter, collect, and discharge embankment seepage. Incorporate major subdrain with tree rootball and stump removal where possible.

Remove all trees located beyond the toe of the downstream slope having stump diameters greater than about four inches. Install weighted filters and/ drain systems in rootball cavities where

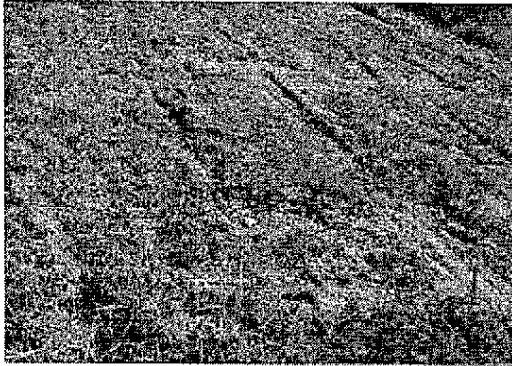
Embankment slopes are normally designed and constructed so that the surface drainage will be spread out in a thin layer as "sheet flow" over the grass cover. When the sod is in poor condition or flow is concentrated at one or more locations, the resulting erosion will leave rills and gullies in the embankment slope. The erosion will cause loss of material and make maintenance of the embankment difficult. Prompt repair of the erosion is required to prevent more serious damage to the embankment. If erosion gullies are extensive, a registered professional engineer may be required to design a more rigid repair such as riprap or concrete. Minor rills and gullies can be repaired by filling them with compacted cohesive material. Topsoil should be a minimum of 4 inches deep. The area should then be seeded and mulched. Not only should the eroded areas be

Figure 1 – Rill and gully erosion

repaired, but the cause of the erosion should be addressed to prevent a continued maintenance problem.

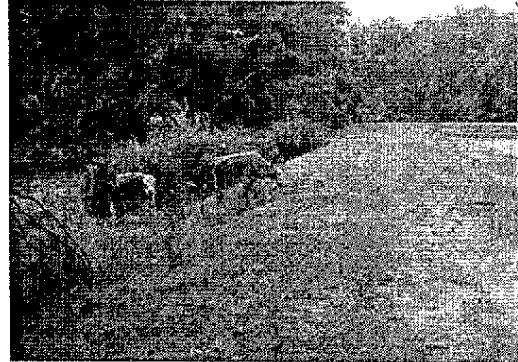
Vehicle ruts can also be a problem on the embankment. Vehicular traffic on the dam should be discouraged especially during wet conditions except when necessary. Water collected in ruts may cause localized saturation, thereby weakening the embankment. Vehicles can also severely damage the vegetation on embankments. Worn areas could lead to erosion and more serious problems. Ruts that develop in the crest should be repaired by grading to direct all surface drainage into the impoundment. Bare and eroded areas should be repaired using the methods mentioned in the above sections. Constructed barriers such as fences and gates are effective ways to limit access of vehicles.

Figure 2 – Animal footpaths and vehicular ruts

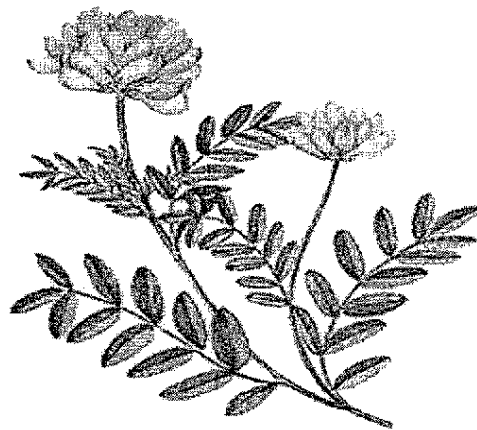
Crown vetch, a perennial plant with small pink flowers, is commonly used on steep slopes to prevent erosion. However, it is not recommended on dams since it hides the embankment surface, thus preventing early detection of cracks and

eroded areas.

Figure 3 – Crown vetch

Vines and woody vegetation such as trees and brush also hide the embankment surface preventing early detection of cracks and erosion. Tall vegetation also provides a habitat for burrowing animals. All improper vegetation must be removed from the entire embankment surface. Any residual roots that are larger than 3 inches in diameter must be removed. All roots should be removed down to a depth of at least 6 inches and replaced with a compacted clay material; then 4 inches of topsoil should be placed on the disturbed areas of the slope. Finally, these areas must be seeded and mulched to establish a proper grass cover.
