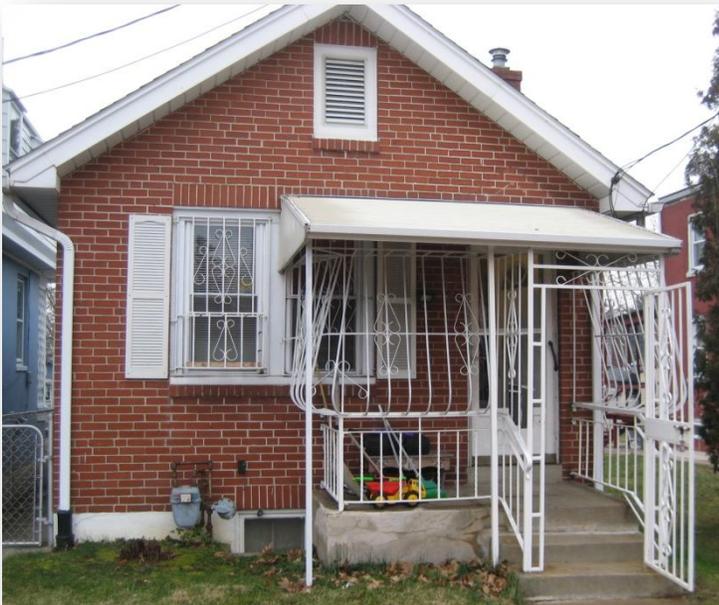
**1200 Block Luzerne St**

Although these cage systems appear formidable, the locking system is usually the weakest point.

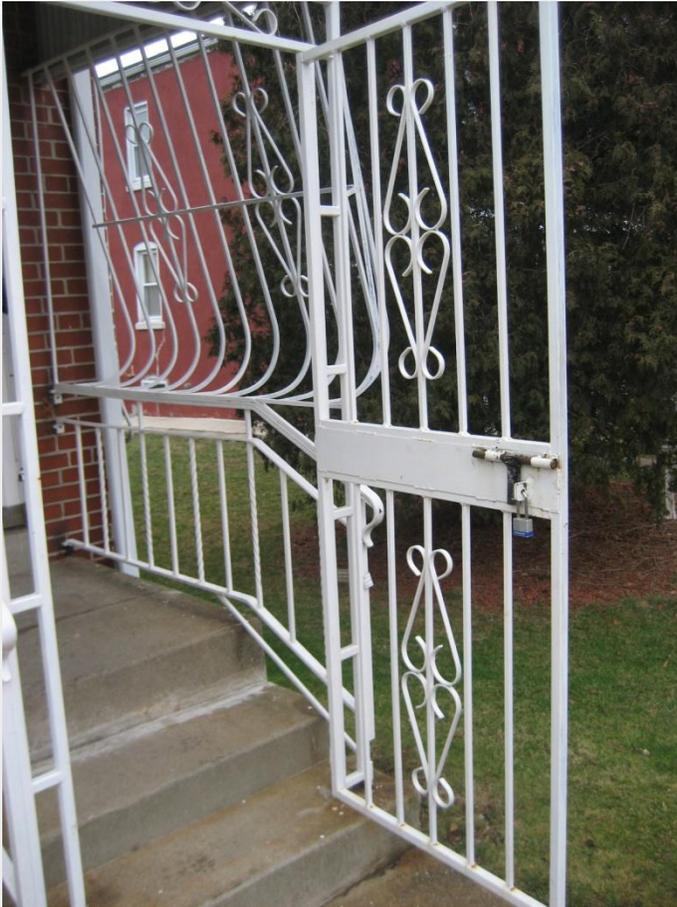
The hasp/padlock assembly is very common on steel gates throughout the city. The hasp is simply connected to steel bolt which is slide into a keeper. The padlock is then engaged to complete the lock.

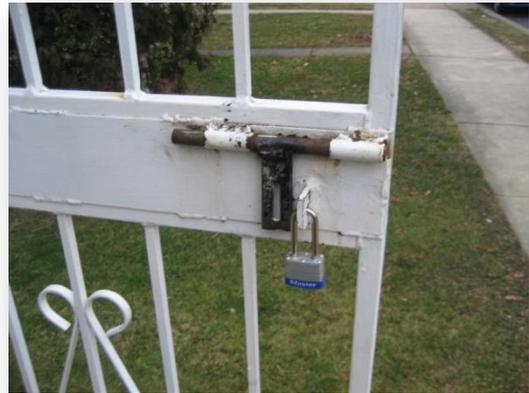
All fire companies are all equipped with a large and small set of bolt cutters. In the example above, the steel provides enough room for the cutters to pass through to be able to attack the padlock. Remember to examine the padlock for the words "**Case Hardened**" those locks are not meant to be cut with standard bolt cutters. Also examine the lock for the "**through-the-lock**" technique if applicable.

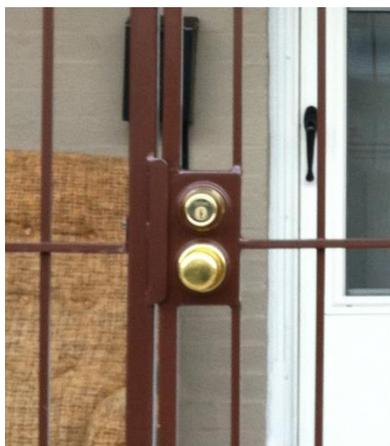
If the padlock is not accessible, or the gate is locked with a standard rim lock or deadbolt we must use alternative methods. The gate on the left is locked with a standard deadbolt. Conventional FE techniques may not work depending on the strength of the material. Although I would consider inserting an adz in between the jamb and gate to see if I could spread the sections far enough apart.

Ladder companies could utilize the through-the-lock technique to quickly gain entry. If things aren't working for you, consider the F.E. saw or hydraulic tool.
